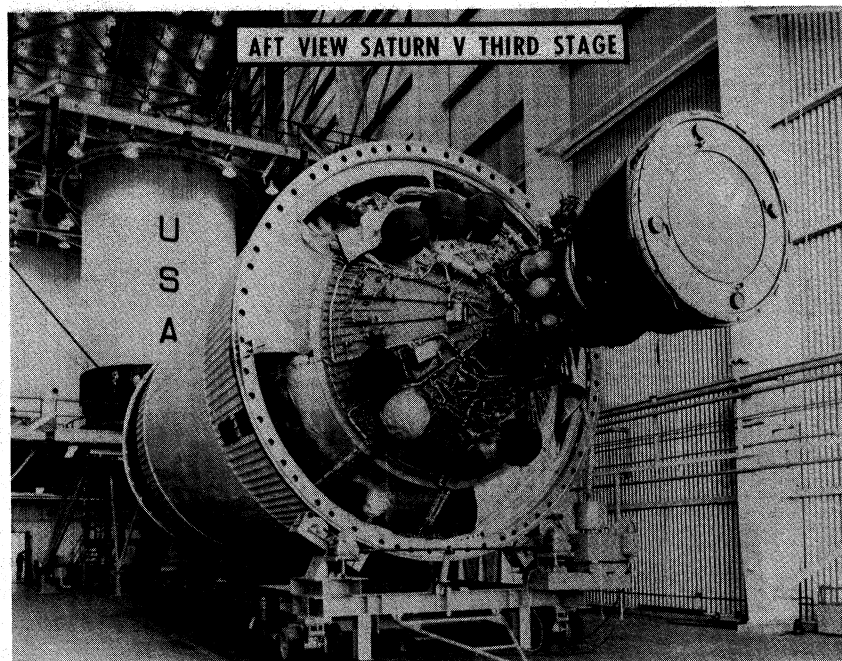
FIGURE 32

to a nominal pressure of 3,000 p.s.i. The purpose of these vessels is to store the pressurants used for propellant tank repressurization for restart. A protective cover is placed over each sphere for shipment and handling. When the stage is static fired, the protective cover is removed.

These spheres are manufactured in hemispheres with an equatorial type weld around the center. These are about  $4\frac{1}{2}$ -cubic-foot titanium spheres. The titanium is alloyed with aluminum and vanadium. During the accident investigation, Dr. Debus and his board reported that the failure of one of the spheres on the third-flight stage occurred in a very clean manner at the point of the weld nugget circumferentially around the sphere where was under some 3,100 p.s.i. pressure (fig. 33). In qualification tests, these spheres have been taking ultimate pressures on the order of some 9,000 p.s.i. and all of the failures have occurred perpendicular and in a jagged manner across the weld (fig. 34). This immediately became a very suspect condition. The weld is supposed to be made with a titanium alloy which is identical to the structure of the tank: namely, a titanium-aluminum-vanadium alloy. The accident board and the people in the laboratories here at Marshall found that some small amount of pure commercial titanium had been shipped to the manufacturer of the sphere; it was used in the weld nugget and as a result, the sphere's structural strength was reduced to 30 to 40 percent. Ten of these spheres had been manufactured with the wrong welding wire; all have been located and taken out of the system.
