FIGURE D-21.—Liquid oxygen line failure.

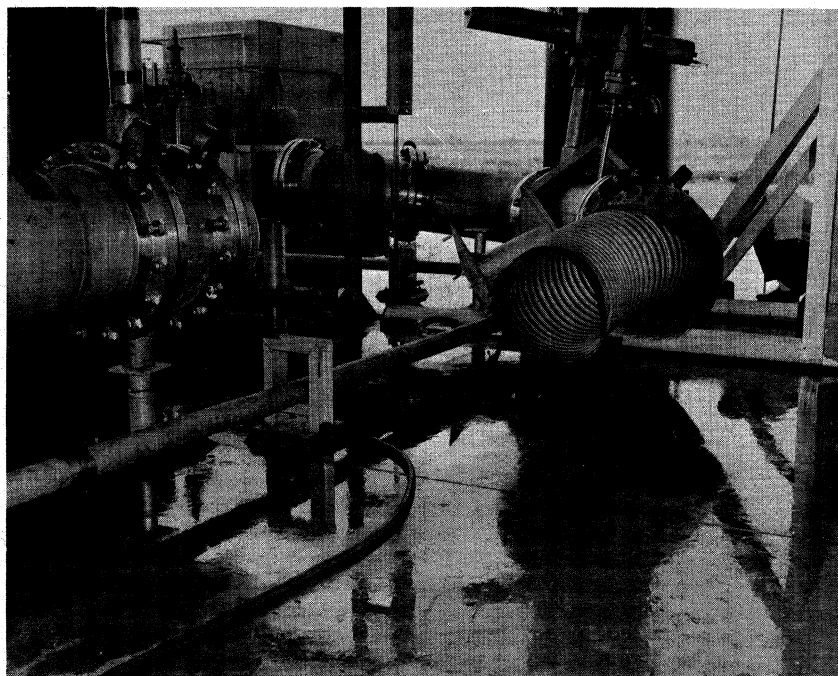
are using 18-inch lines. Nobody has transported liquid oxygen at that rate through 18-inch lines before.

This particular break occurred on August 20. In 1 calendar month, September 20, this particular liquid oxygen tank had been refilled, the correction of the deficiencies had been redesigned, and it was back in operation.

Mr. SHINKLE. Experiments were conducted on opening the second valve very slowly to allow the built-up gas to escape without creating the severe shock of impinging with the liquid oxygen. These experiments failed, since upon slight opening of the valve the quick release of gas occurred and the shock forces were again experienced. Therefore, we solved the problem by installing the recirculating system, which eliminated the gas build-up at the valve interface.

Mr. SHINKLE. No. A recirculation and precooling system was installed in front of the second valve so that there would always be liquid against the face of the valve rather than gas.
