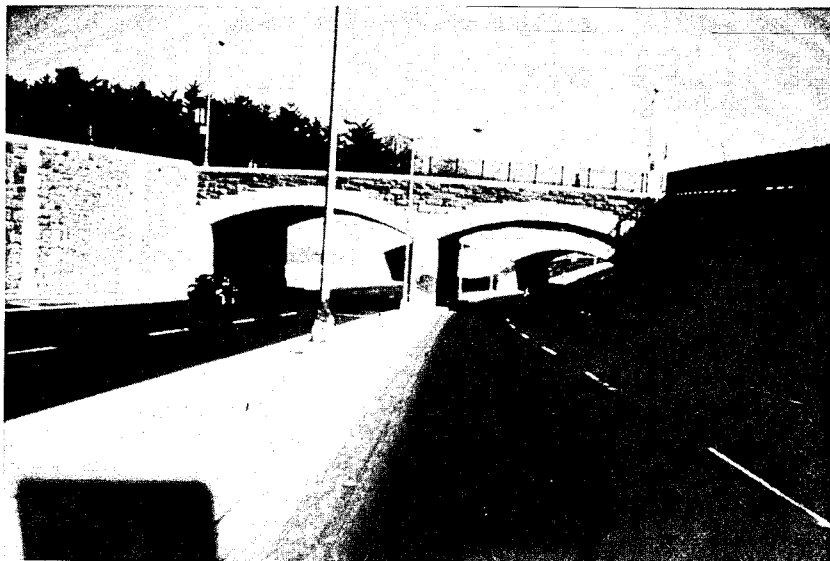
Mr. LINKO. It's in the Bronx, near Fordham. As you see, we built all of these unnecessary obstacles. This is a depressed highway, and most of the people won't see any beauty here. Here you are coming down the road, and you have a low 5-inch curb. People have crossed over this low median, knocking down two or three of these lights; every one of those bridge abutments are exposed.
