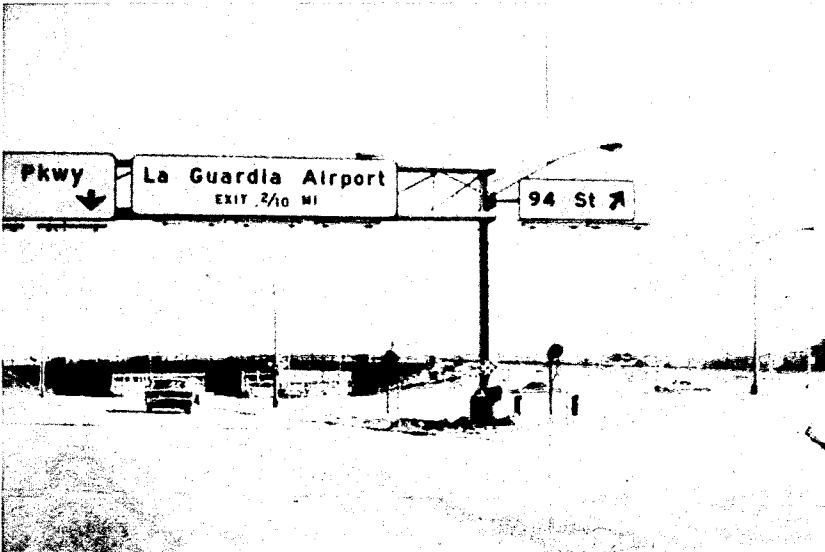
But this is what they do in my area. They have saturated these gore areas with heavy concrete stanchions. This particular guardrail was smashed into 2 years ago, and it is still lying there. I feel, at this point, I would like to say that we should have maintenance on our highways. They ought to replace the light pole in 48 hours if it is knocked down. The guardrails are given out by contract every year or every 2 years,
