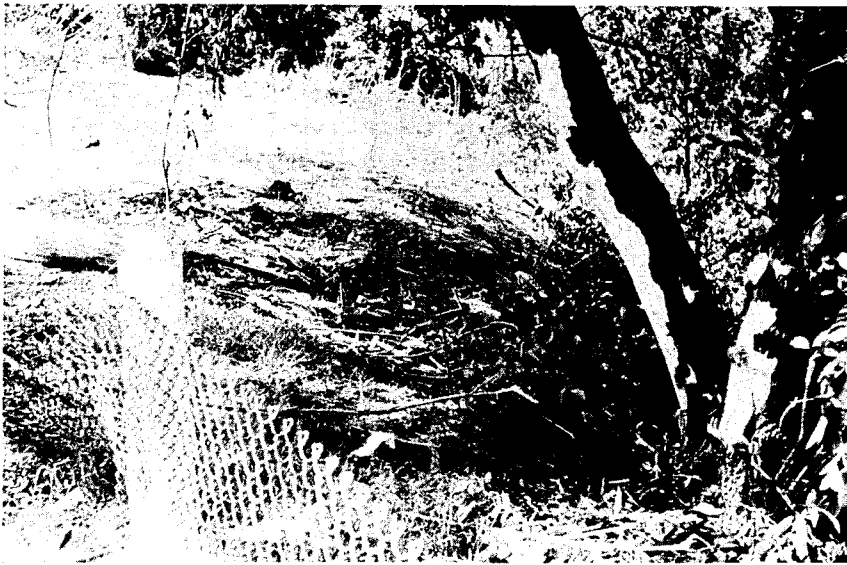
You can see the impact point and the lack of adequate supports of the guardrail and the chain-link fencing.
