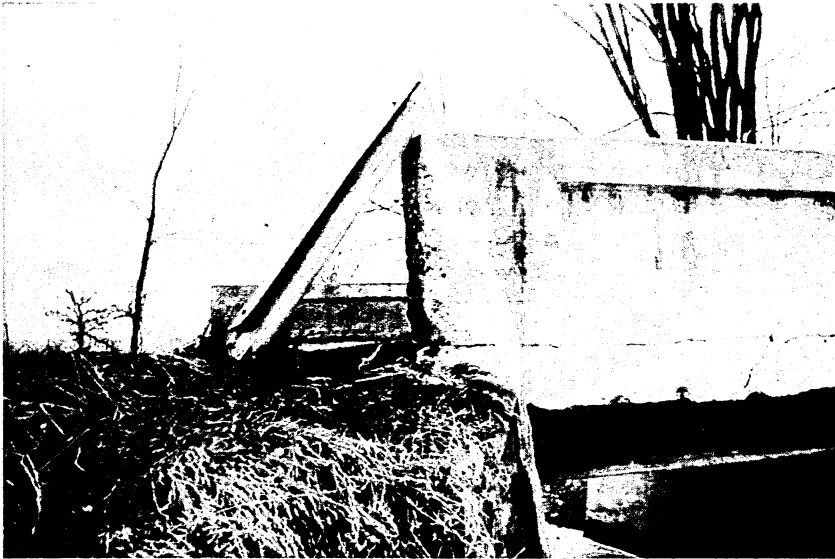
The sign was mounted on a breakaway wooden post that absorbed none of the energy.
