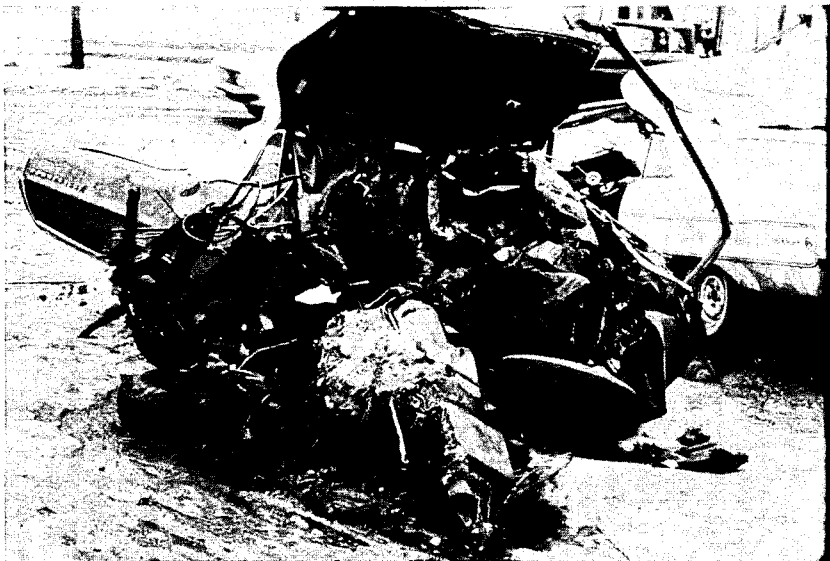
the road is beyond it. This is the engine area. This is a Pontiac convertible. The front bucket seat is fused to the rear seat. The post was knocked over at maybe—not even a 45-degree angle. The engine is 65 feet in front of the car. And the instrument panel is parallel with the left side of the car. The driver was found killed.

This is obviously an immovable object, which literally just sliced through the car, causing the death of the driver.

This gives you a better idea of what the car looked like. Notice the front bucket seat here fused into the rear area, instrument panels all along this left side of the car.

A fatal accident. It is interesting to note that both of these sign legs were taken down and now we do not know where the Flint exit is any more, because they never bothered to replace it.

Had this sign been set back 20 to 30 feet, this individual would have gone down that relatively smooth embankment for a considerable distance, but it could have been a survivable, off-the-road situation.
