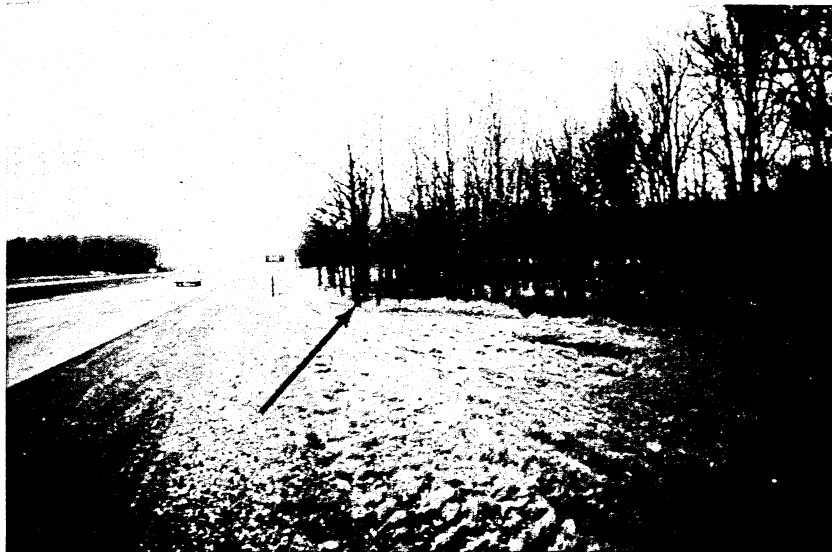
Dr. HUELKE. As we proceed farther on the roadway, we see that here the trees are fairly well cleared back. This is going back maybe 50 feet or so, but only a few hundred yards farther down the roadway, we see that the trees are very, very close to the road area. So here we have differences on the clearance of the trees; and these trees are, as I have shown before, quite hazardous.

Here, again, we have a very clear offroad area, but look at that lone tree sitting out there, and that tree measures at least 28 feet from the edge of the road.

Mr. W. MAY. Mr. Prisk, that water we see, does that present a problem?

Mr. PRISK. Yes. A vehicle would not go through very much water without turning over or otherwise going through an abrupt deceleration, which could cause injury, at least.
