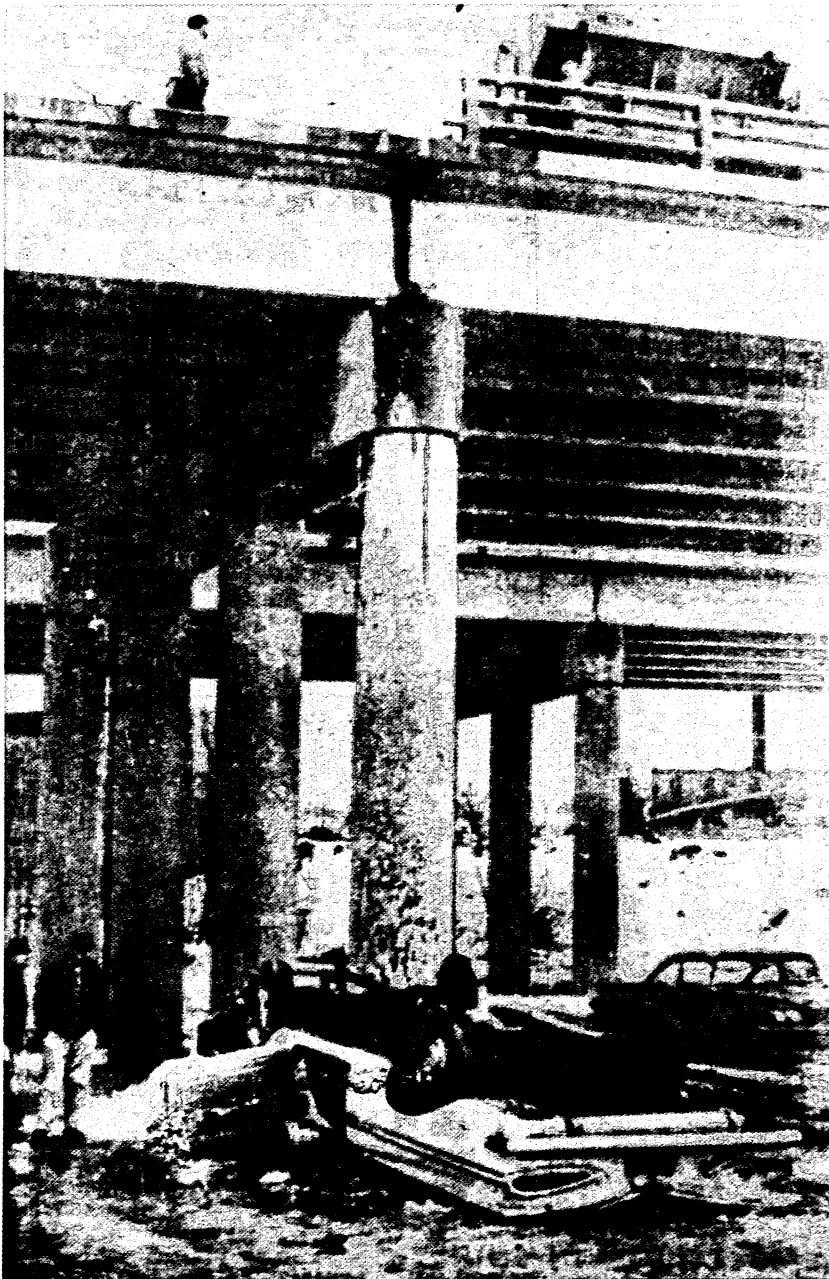
A car ran through this bridge railing and dropped about 30 feet. These particular bridge railings are made of aluminum alloy. I feel they have no business using this kind of material on a high-speed road.
