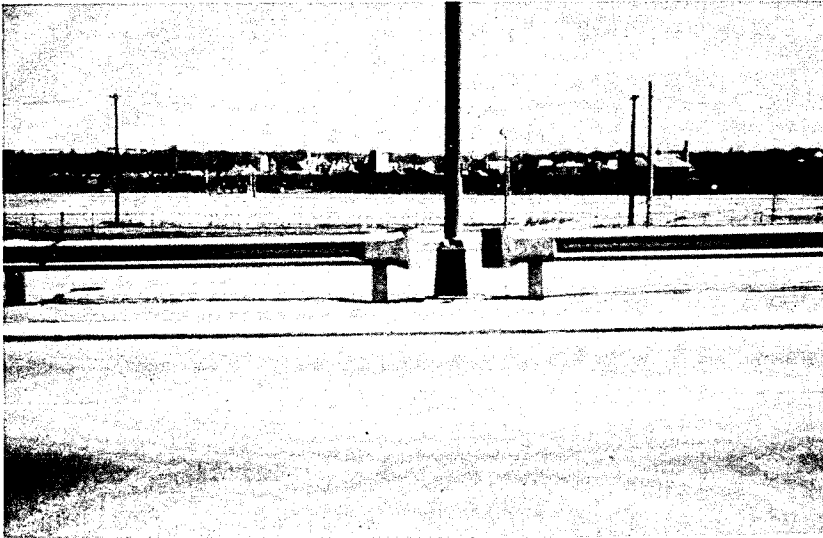
And here you can see the base sticking out. The rail ends where the dot is. Someone slammed into that and knocked down a light pole.

Because you do not have continuous rail to utilize the full strength of the steel railing, we get a lot of unnecessary damage and the light poles are going down anyway.

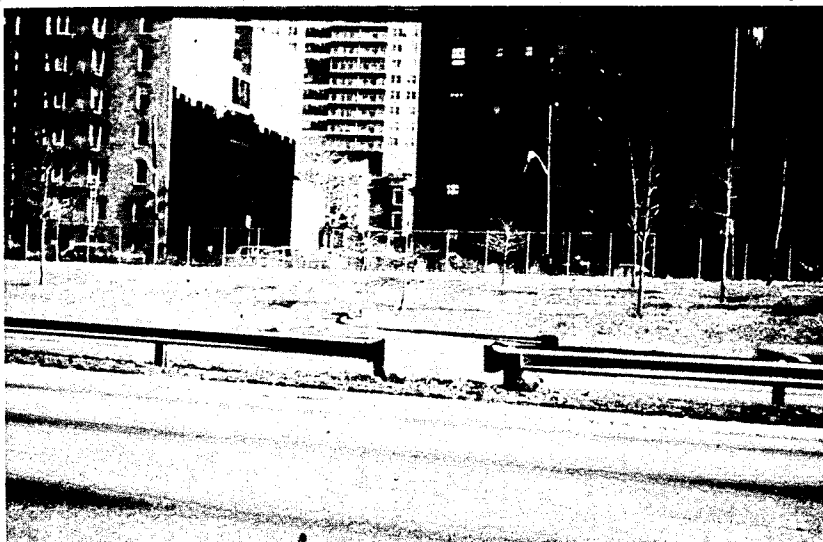
This is what I am talking about, you see. That seems to be the standard installation.
