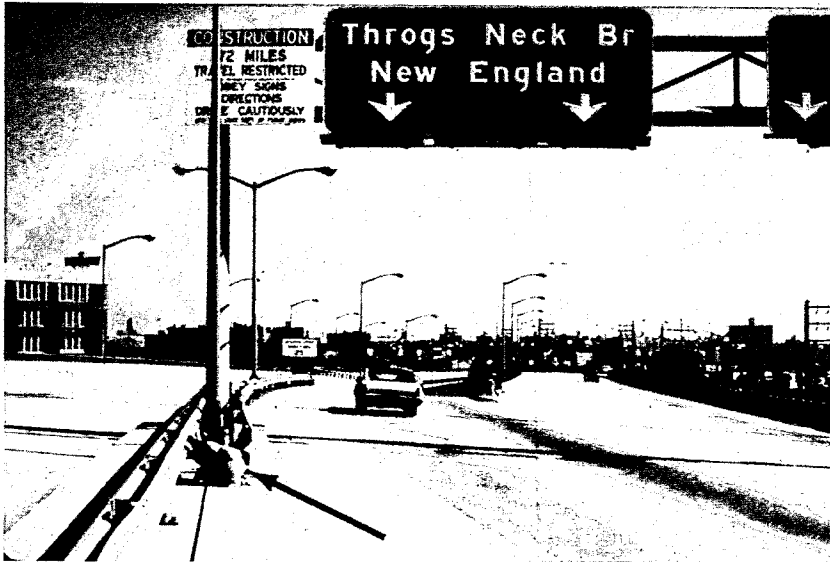
Here also it was not bolted to the railing. Even though it was near it, that means nothing. You have to phase it out, and bolt it to the railing. Instead of getting a scratched fender, a car is badly damaged.

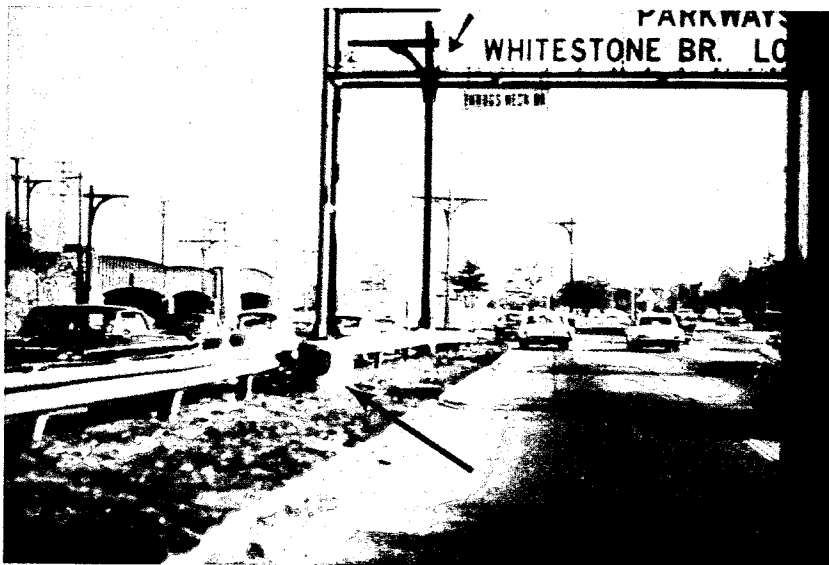
This is what you see. The material is there, but installed wrong.
