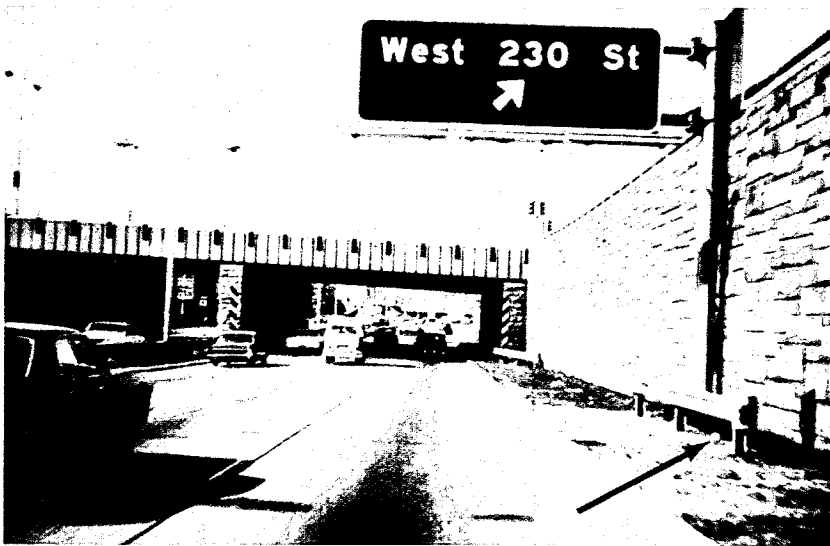
Up ahead at the underpass you can see where the rail was phased into the wall. However, see on the right where they didn't protect another hazard.

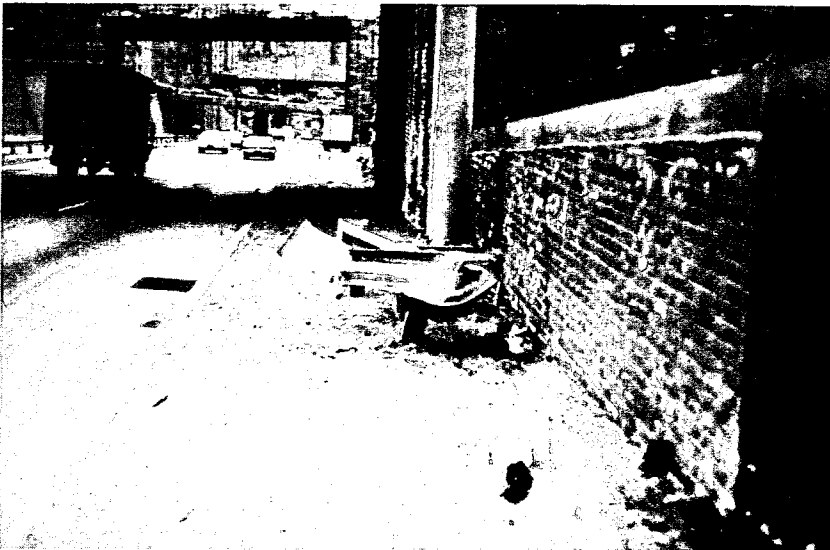
Here you see a place that has been hit. It could have been a scratch, but because of this it wasn't.

By the way, this particular installation has not been repaired for about 6 to 8 months. Once you hit it, it lays around until a big contract is given for an entire section.
