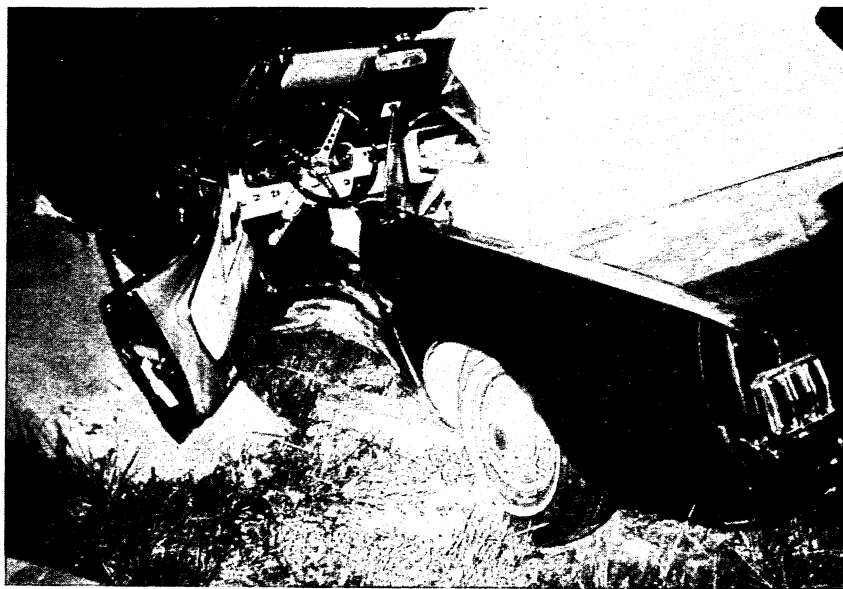
Mr. O'HARA. This vehicle ran into a sign similar to the one we just looked at which had the concrete exposed above the ground. And in this accident there were a number of injuries. The police officer who gave me this photograph was not sure whether it was two or three but it was serious, and this accident occurred in 1966 on the Capital Beltway.
