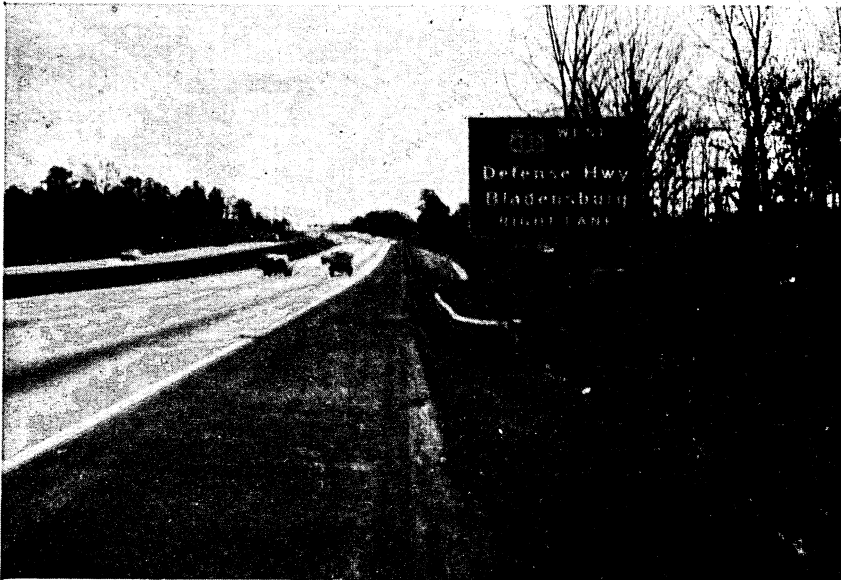
Now, jumping over to the Maryland side of the Capital Beltway, this is a sign installation which you will find along its 42 miles. The sign here is mounted, not on a steel pole, but on an 8- to 12-inch steel I-beam. The size of the I-beam will depend on the size of the sign. This particular one happens to be 8 inches, and again it is embedded in concrete. Concrete can be as much as 5 feet into the ground.

Notice that the road in this area is fairly straight. There is a drainage ditch here and fairly steep backslope [indicating].

Mr. PRISK. Yes. Certain designs on the roadside call for a rather rounded section of the ditch, flat-bottom-type ditch. This appears to be a V-ditch.

Mr. PRISK. This very well could happen. That is true.

Mr. O'HARA. As regards this particular sign, following is a photograph I took in December 1966.
