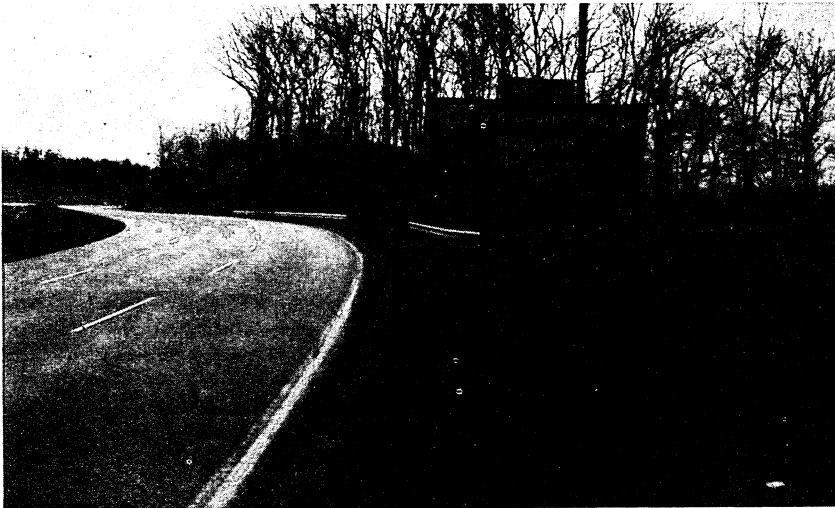
Now this installation of guardrails is typical of what you will find in Maryland. This particular scene is just west of interchange 19 on the Capital Beltway in Maryland. And look at this area, if you will.

You have a road which is curving at this point slightly to the left. Here is a fixed object, a steel light pole embedded in concrete. Here is the end of a guardrail meant to shield this sign. Yet there is an open space in here. The guardrail could have been longer. It could have come down here [indicating in front of light pole]. Here they have discontinued the guardrail for a distance of 40 or 50 feet [indicating beyond sign].

There is a drainage area in there. They could have carried it in here [indicating between two guardrails]. Back beyond the end of the guardrail here is a speed sign, mounted on two 4-inch I-beams, which could have been moved up behind the guardrail.

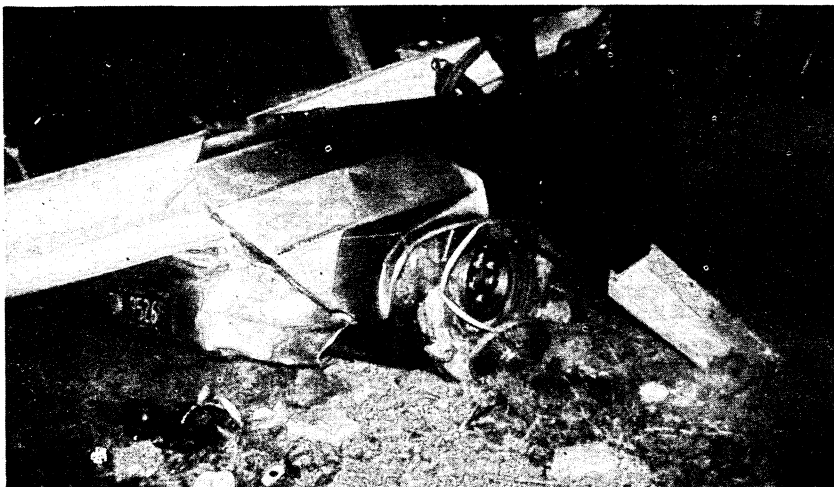
This is what happens when a vehicle hits a guardrail.
