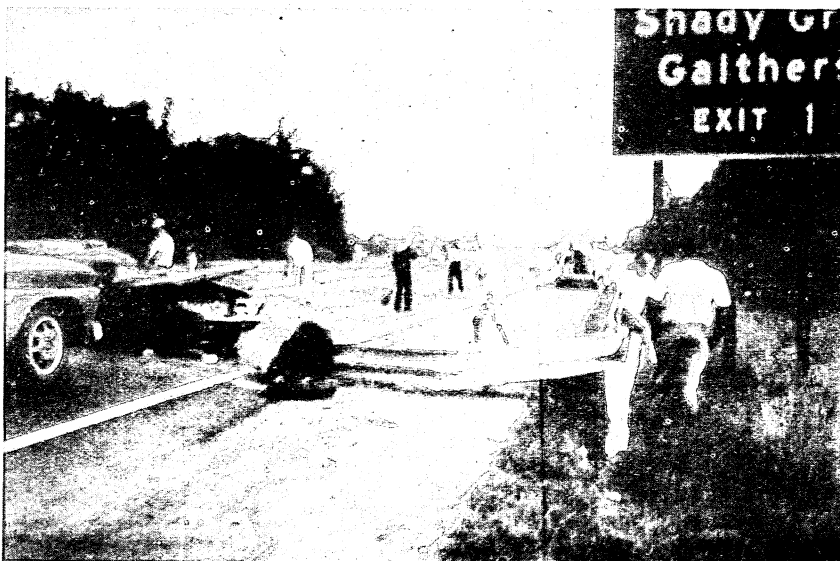
A couple of months later a similar accident occurred on Interstate 70-S, and I show this photograph only to show that this guardrail installation is typical of what happens on the beltway and other roads.

This guardrail which was facing us, as we are looking at this scene, is the end of the guardrail. This is the vehicle which ran into it. And in this case you notice that the sign is mounted on wooden posts. The runoff area is fairly smooth. It is not even, but it is not a deep drop either.
