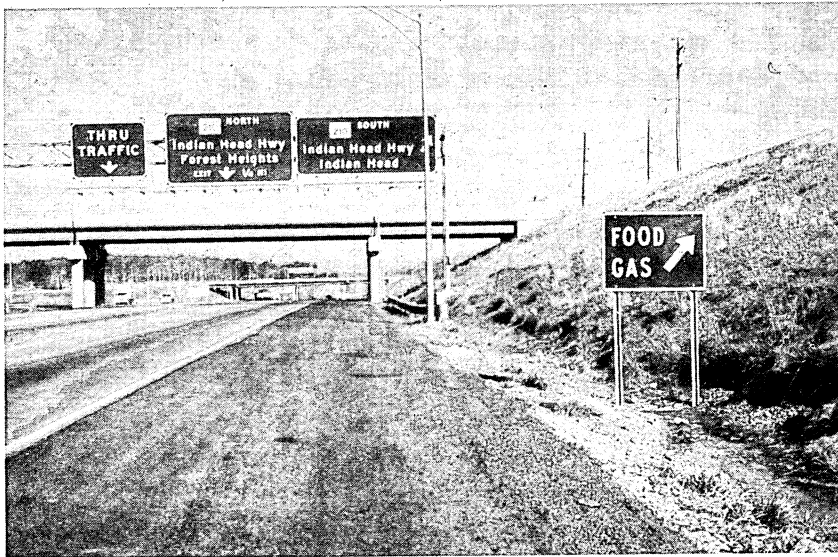
Here is your gore area. This is very even, and yet the sign is in there, mounted on steel poles, while over on the shoulder—this sign could have been mounted and cantilevered over the roadway somewhat in advance of this gore area.

Just beyond this you see the merging traffic sign, again mounted on the 4- to 6-inch steel pole.
