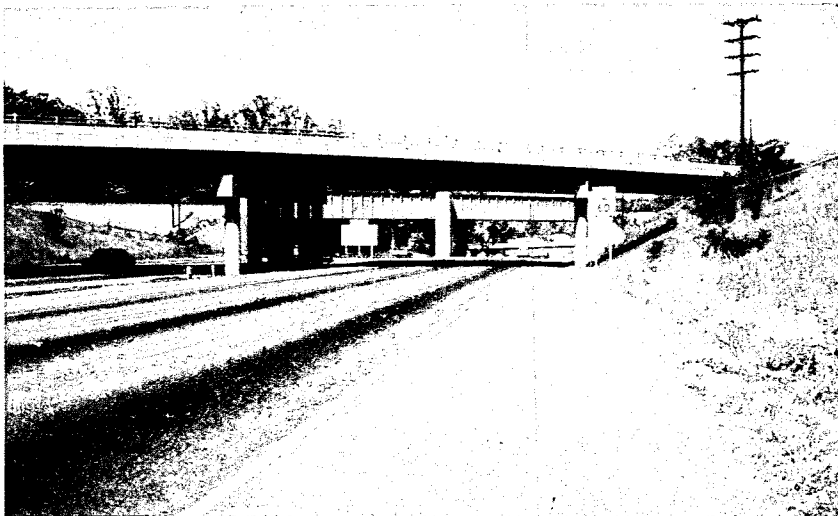
This is the next overpass just beyond the B. & O. Railroad overpass. There is a guardrail protecting the concrete piers in the median. On the shoulder there is no guardrail. However, there is a small piece of guardrail beyond the piers, but it ends just short of the light pole.

On the left or westbound side, there is a sign but with no guardrail, and in the median there is no guardrail. This area I thought was important. I wanted to show you these three structures to point out the inconsistencies in guardrail treatment.
