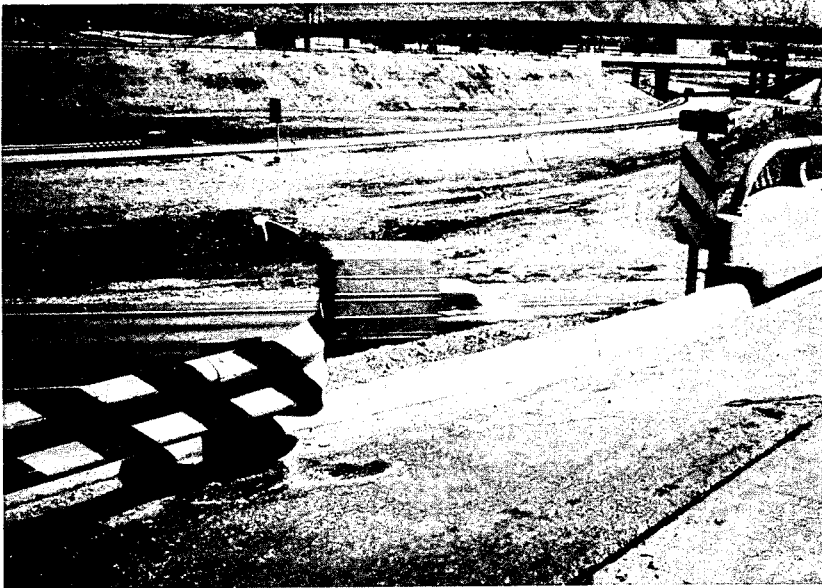
Mr. PRISK. Here is another similar hazard where the rail is there on the approach to the structure, but you have got a pretty good gap there to get through. I don't think you would have to have a small vehicle to get through that gap.

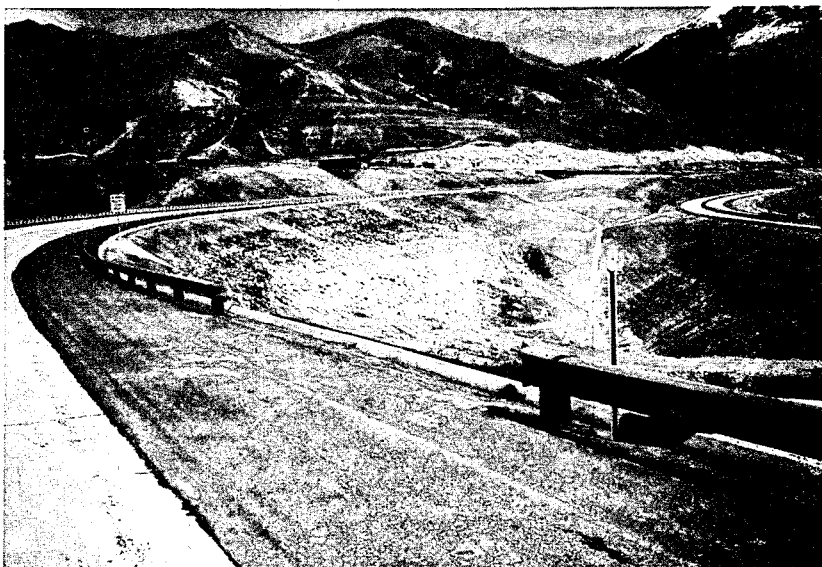
Here is another gap in the rough terrain that I spoke of, between two rails. Originally the contractor used a roadway across here for construction hauling and that section appears to have been left open—is still left open for turnarounds.

Mr. WILSON. On that last slide, I would like to point out a good thing about this installation is the fact that the curb, or dike, normally
