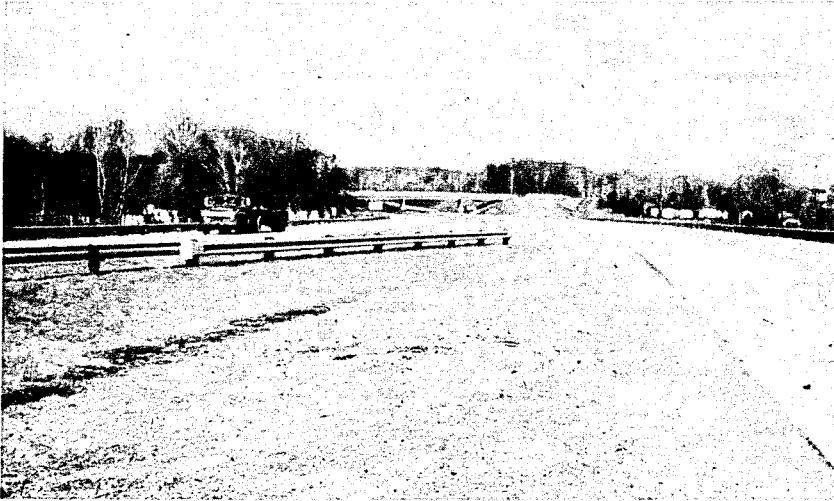
Mr. PRISK. At the same time, I call your attention to the head-on posture of the rail on the right-hand side of the road.

Here is a treatment on the end of that median flare that is doubled back so that actually for about seven or eight panels you have protection on which ever side you hit it, going in the direction of the camera shot or in the opposite direction.

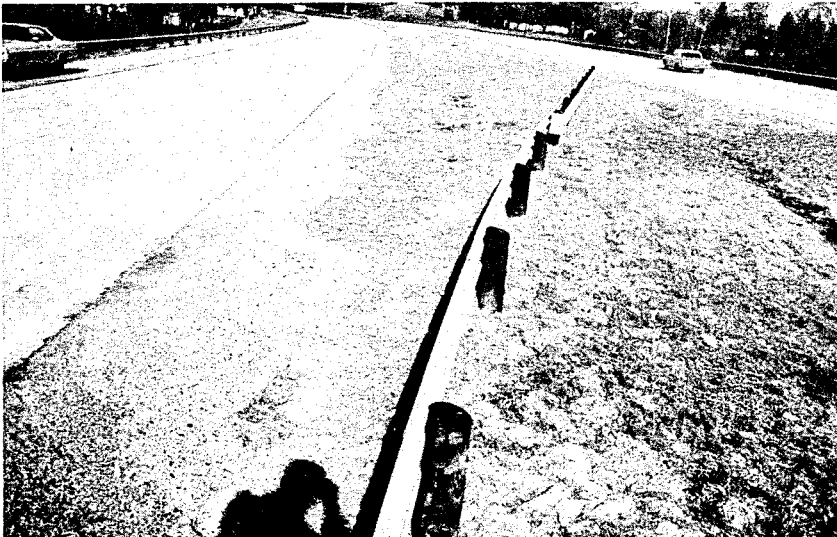
Now we move to Montana and find about the same situation.

Mr. CONSTANDY. Mr. Prisk, that would be I-90 and this section was made up of three projects, two of them being opened in 1966 and one in July 1966, 11.2 miles total. This is just on the edge of Missoula.
