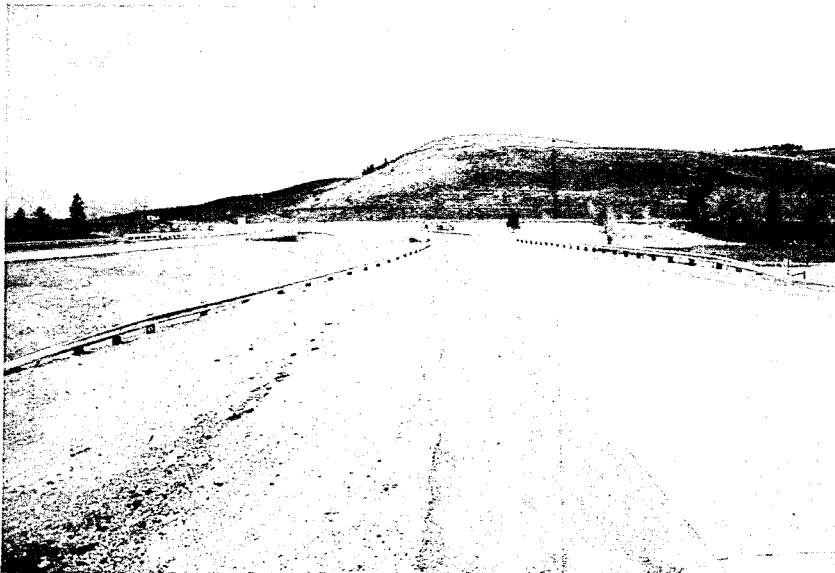
Here is an approach to a dual structure in Montana where there is a flare carried well down into the median area.

Mr. RICKER. I think it would be desirable to take some of that swale out at the locality where this guardrail begins, to avoid this not-too-good effective section of rail, where you are going down the slope and hitting the rail at the same time. You wedge in there.

Mr. CONSTANDY. Apparently there is good reason to flare the guardrail on the left, as it is, to prevent the motorist from meeting the hazard between the bridges, but there is a like hazard on the right side. This seems to be followed in many places, the median side is considerably flared and the guardrail on the right-hand side is not. I wonder if someone would care to comment on that. It perplexes me.

Mr. RICKER. I notice in the picture there is an embankment down near the actual opening which provides a second line of defense for somebody who does happen to get in there. That is as good a place to
