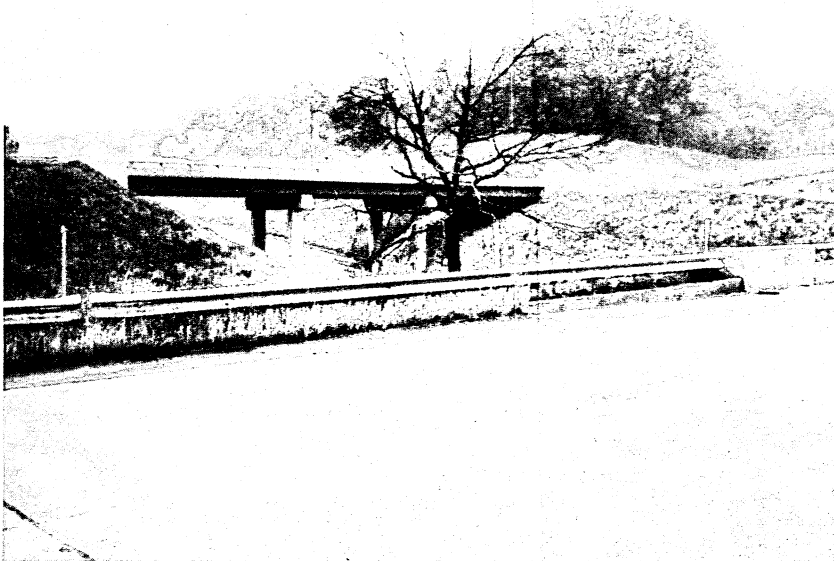
This, again, is a general view showing the median section, separate line and grade, installation of rail here, evidently at a fill height which corresponds to the Georgia standards. This fill here, of course, is not as high, but it apparently meets the height here [indicating]. So meeting the standards here, that section is in. The same thing over on that side.

Mr. PRISK. On the right side? No, I think, as I recall that location, that it is quite a dangerous drop at that point.

Mr. HUFF. Is that a drainage structure this side of the barrier?

Mr. PRISK. Yes, it is. There is a minor drainage structure right there at the trees, right in this area [indicating].

Mr. SKEELS. I was going to add, the trees give you far more hazard than the slope up where the guardrail is. The guardrail really ought to be down there protecting motorists against the trees, rather than against the slope up above. That slope, in the slide anyway, does not look lethal.

Mr. CONSTANDY. Would it have been more desirable here to eliminate the guardrail from the median and use that material?

Mr. PRISK. I should think this could be considered certainly as an opportunity to regrade the median at that point.
