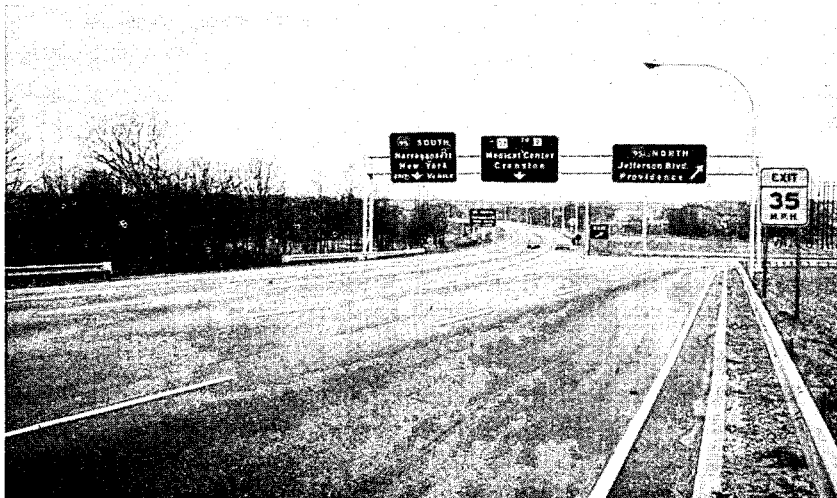
Mr. SKEELS. I want to call your attention to one other item in this photograph. These posts are spaced at 6-foot-3-inch intervals, which means that one of the posts occurs at a splice portion; the next one occurs at a position where the rail is not spliced.

The spliced portion on the rail is two rail thicknesses thick. At the intermediate post, then, there is only one rail thickness involved.

In our test at GM, we have had several occasions when a car impacting a rail at a point where it is not spliced will tend to cut the rail in two in a shearing action at the mounting point, and it is our practice to put in a doubling section. In other words, a short section of rail about a foot long to act as a doubler at the point where we attach to a post, where it does not fall on a splice.

Mr. SKEELS. It is a very cheap little thing. It does not cost much except a little foot of rail at each one of these, and it does prevent shearing action.
