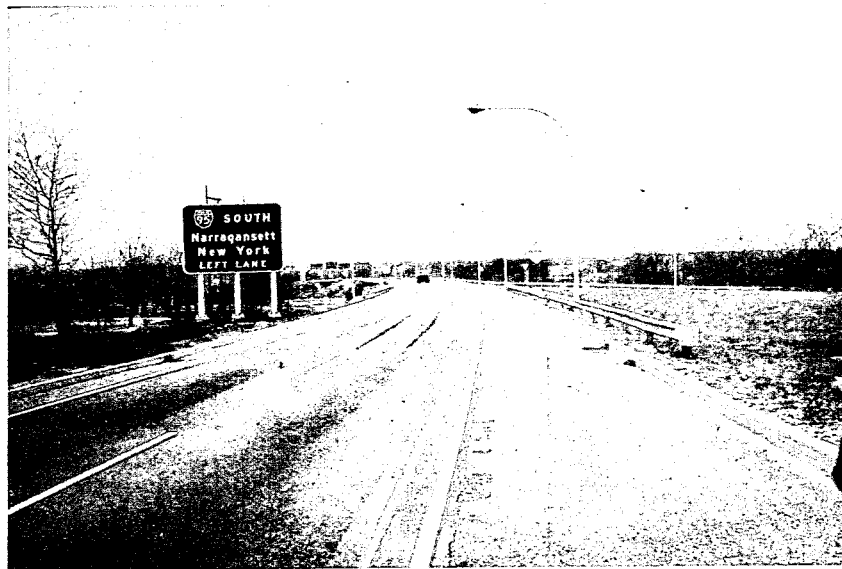
Mr. PRISK. Here is another one. Behind the curb you have a blunt end of rail. In this case these are aluminum poles which, elsewhere along on this project, are left exposed very frequently, but in this case railing is put in there. It is a little difficult, again, to see the reason for that installation.

On the left-hand side, you find the sign that might warrant some shielding, because of the fact there are concrete bases somewhat above ground and very husky upright supports, and there is no railing at that point.

Mr. SKEELS. I would just like to emphasize the undesirableness of mounting rail on top of curbing. Or to put it another way, to place curbing in front of the rail. This does nothing but encourage the car to get on top of the rail and make the rail ineffective.
