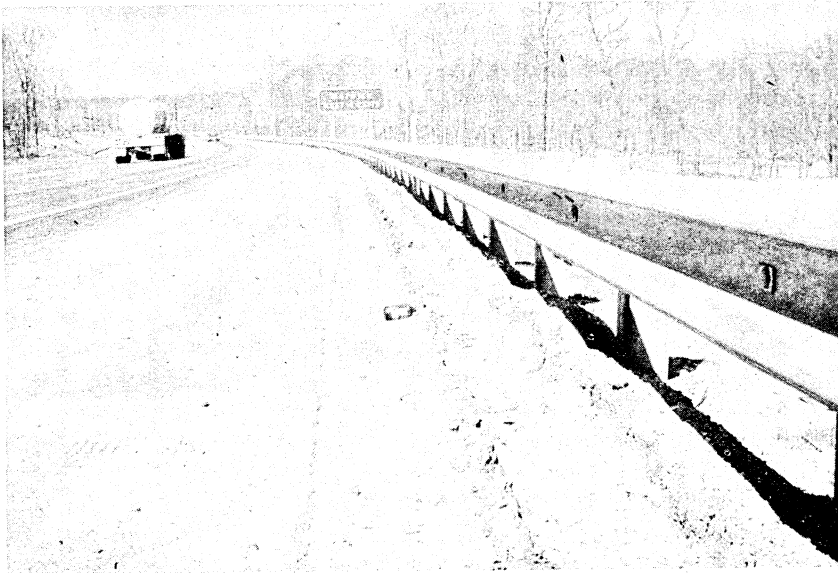
This is a section of the side rail also showing how people get into this area, like it or not. This is shoulder here and this is just dirt, churned up and muddy. Well, muddy certainly in wet weather, as these ruts tend to indicate. And I suspect that the performance of rail with that kind of surface in between cannot be too good.

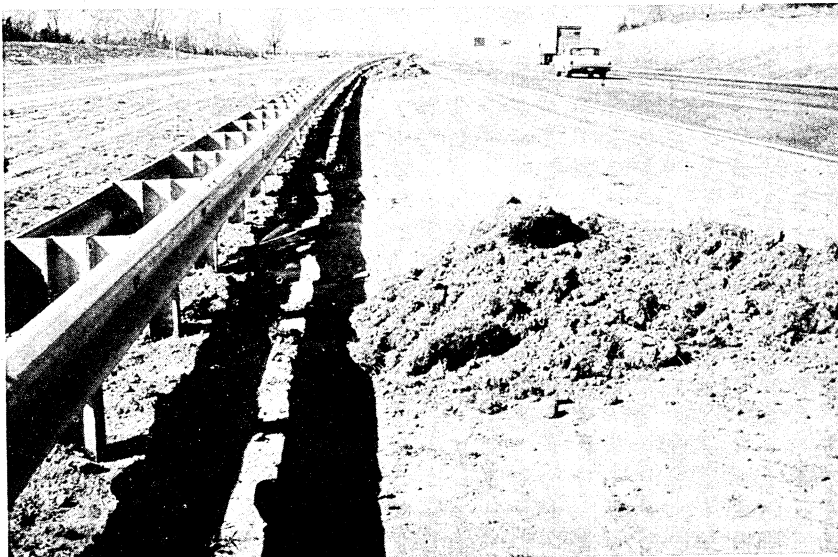
There are washers on this median divider, which runs right down the middle of a fairly wide median, in the process, as you can see, of landscaping, completing work, finishing work on the median area.
