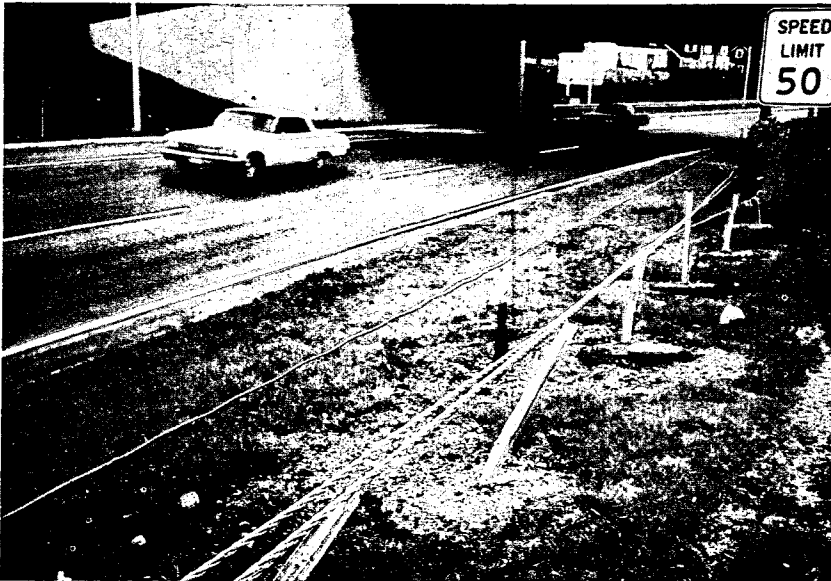
Mr. PRISK. Here is an installation where it actually was hit. This is not the same location, but this is the same type barrier without the glare shield in it, and the car was decelerated and knocked down about six or seven posts and presumably came to rest at that point. This is on a section just off the project.

Mr. CONSTANDY. Although it does not show very well in this picture, what the automobile does is cause the chain link fence to bunch up in a big wad, is that not right, Mr. Wilson?

Mr. PRISK. It is in a pile down here [indicating].

Mr. WILSON. Incidentally, we found the chain link fence itself was not an essential part of this barrier. It performs just as well without it.
