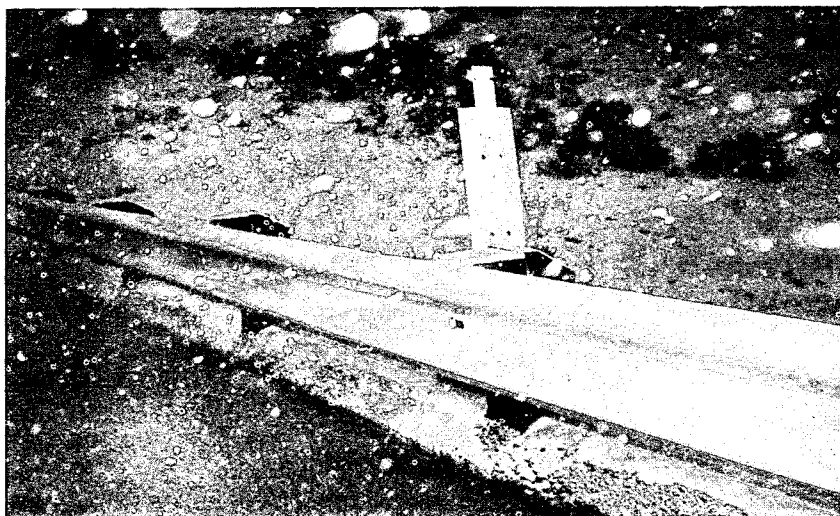
Here is a picture taken under very severe conditions—snowflakes you see there—but again showing the rail and the blocked-out position of the rail in relation to the paved surface.

Mr. CONSTANDY. It loses some of the contrast in the snow, the painted rail.

Mr. WILKES. Was that a curb at the face of the guardrail?

Mr. PRISK. There is an asphalt curb right at the face of the guardrail.

Mr. CONSTANDY. That is not throughout, though, is it?

Mr. PRISK. No, just along embankments and along structures, principally.

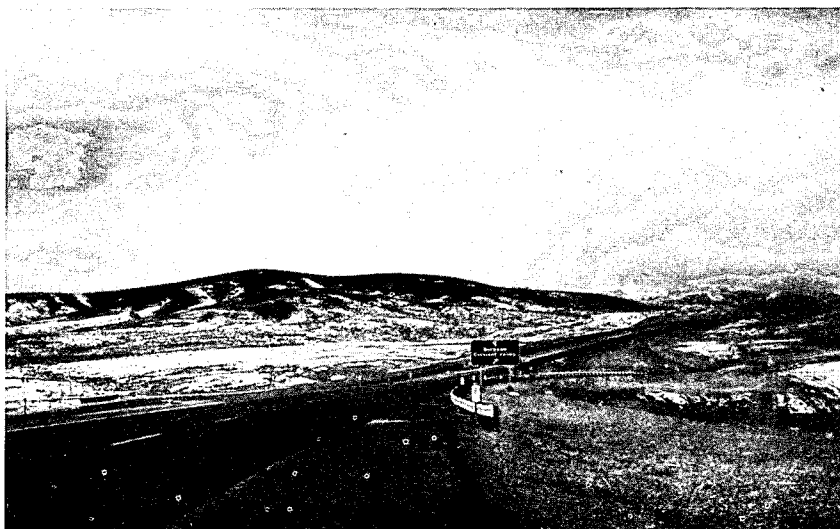
Here is the approach to the only interchange there was on this particular job we looked at, few and far between there. You will see the
