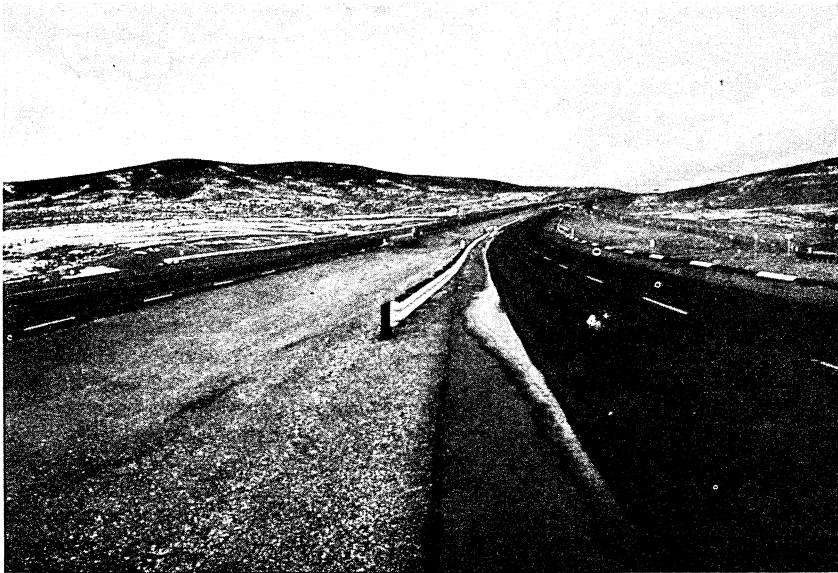
Here is another view showing the small amount of flare that was used there.

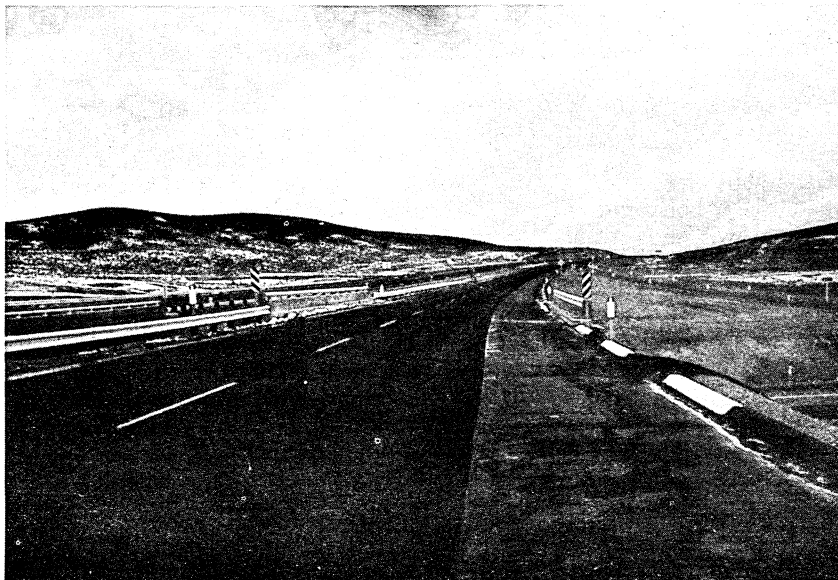
This I think perhaps is one that I would call your particular attention to, because of the fact that this [indicating]—this is the one interchange structure on the project and for some reason it seems unexplainable. Even at this point in time, a month or so after we looked at it, there is no approach rail along this embankment as you move toward the parapet end of that structure. There is one on this side
