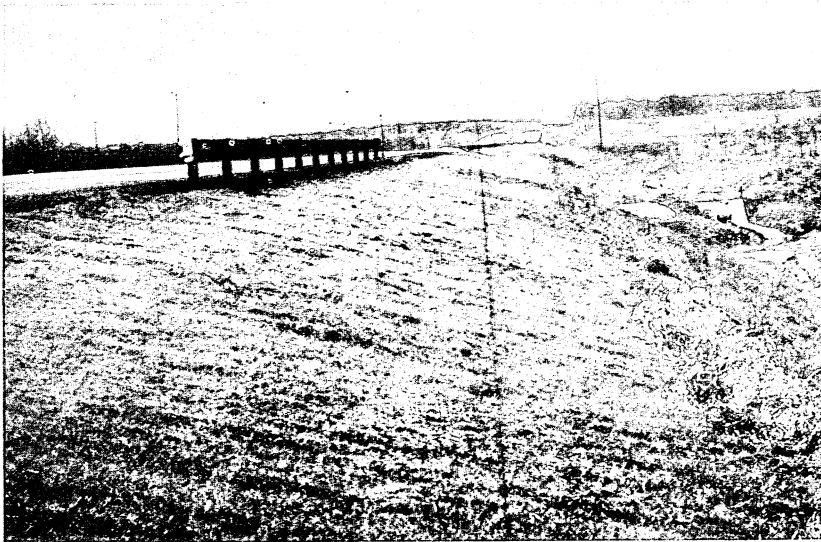
Here is a fairly short section of rail installed at the outer edge of the shoulder, and it is a recently completed and opened project, early this year now. I think we continually have to remind ourselves that these are very new projects; quite short.

You will see the reason for the rail. There is an extremely large pipe that goes all the way under the roadway here that is part of the irrigation system, of the drainage system, for the surrounding land. But in the process of protecting motorists from getting down here to that hazard and the headwall that you see here, a fairly short rail was installed.

I think you can conjecture, possibly, that this slope is a traversable-type slope and perhaps this introduces more hazard than it is worth.

Mr. SKEELS. It could have been carried out another 20 feet and eliminated the hazard for all time without the guardrail. The guardrail is certainly contributing more hazard than it is remedying in this case.

Mr. SKEELS. That slope looks real good.
