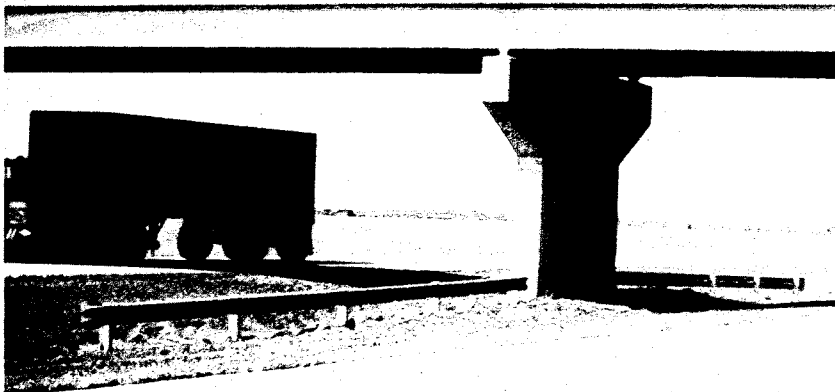
Here is the median side in a little more detail; 50 feet of rail.

Mr. CONSTANDY. Mr. Skeels, I was only going to add, these are all too typical. They are fairly common. They are not unusual.

Mr. WILKES. But I would like to observe it is in the right position. It is near the middle of the median and it is not at the edge of the paved shoulder.

Mr. CONSTANDY. That is true. I think that is worth while in light of a few of the pictures we have seen; it does leave something to be desired, however, the guardrail itself. Mr. Wilson, would you care to comment on this?
