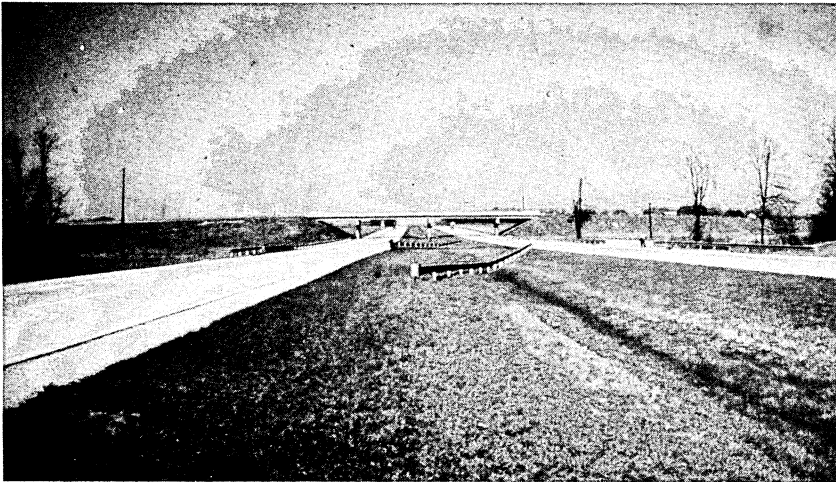
Mr. PRISK. Here is a closeup of the protection at the twin bridges showing how the approach rail has carried across the center of the median, also doubles back for a number of panels.

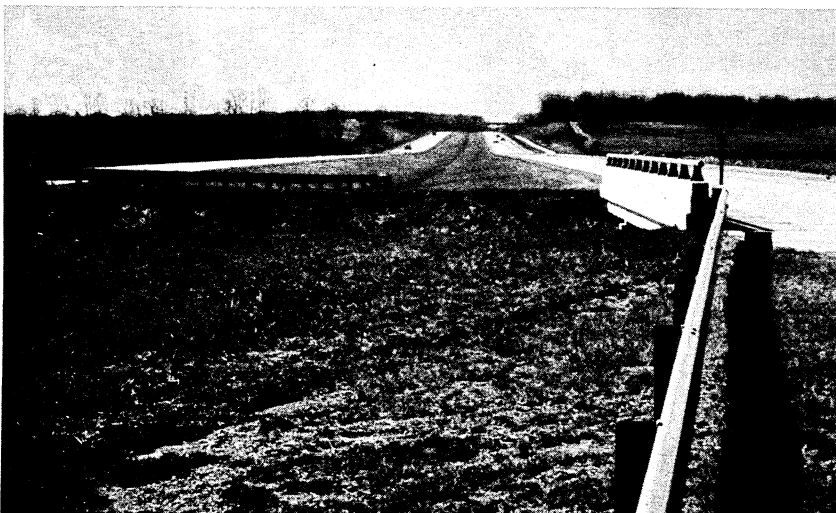
This is the way it looks as it reaches the structure itself.
