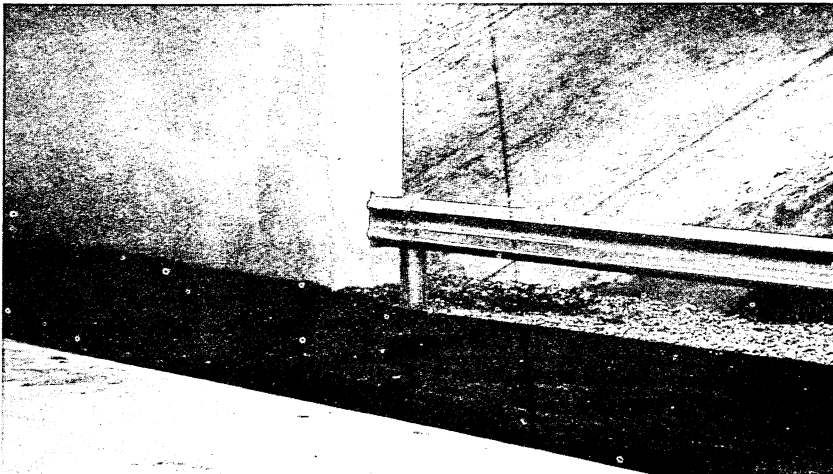
Mr. PRISK. As you reach the structure, this is what you find—no anchorage post driven close to the side pier.

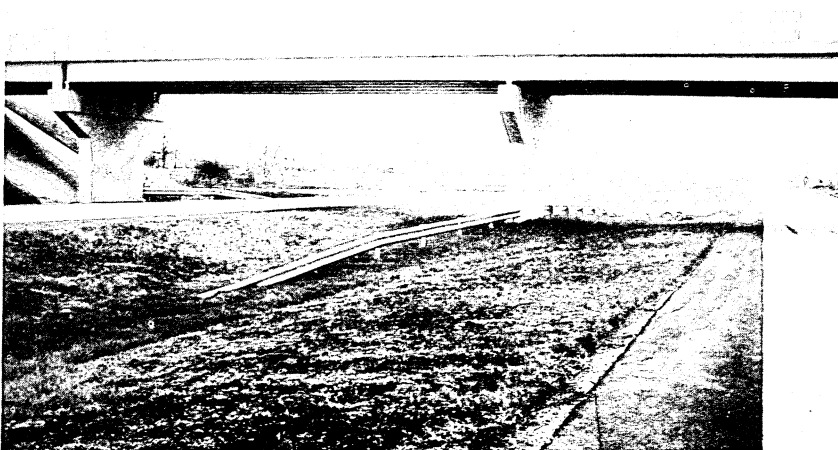
On the median side, this is what you have. Again with an extension from the previous job that we looked at on I-69, which stopped here
