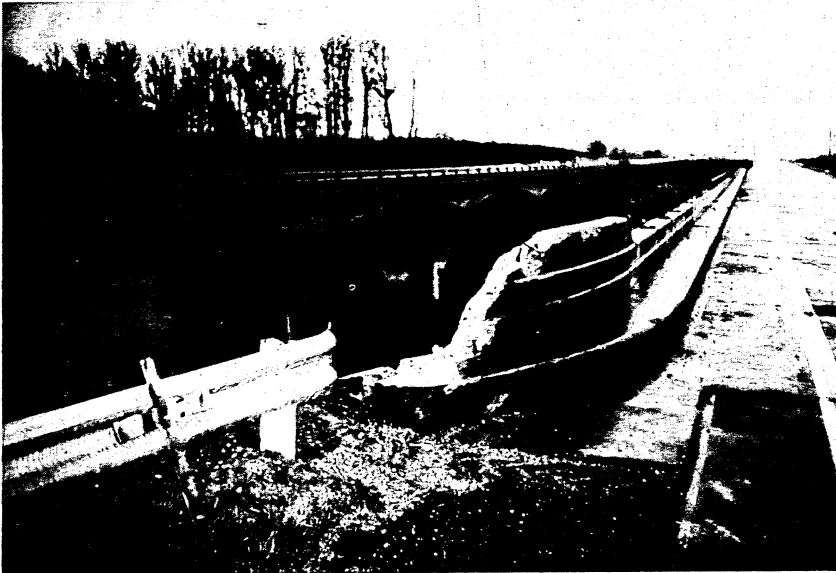
This is the bridge where the fatal accident occurred, which is very close to the project.

And this is another case. Here another fatal accident actually occurred. As you will see, this bridge was hit hard enough to take away not only a portion of that end wall, but a very considerable length of the rail running on up to the bridge.

This was obviously a very severe collision.

Another view of this same accident location. Here the rail came to an end stopping, and with that terminal section on it, flared back. This did bring the car in violent impact causing two deaths at this point.
