Looking now at a brand new project, not yet opened, and also at this same critical point of junction of approach guardrail on the roadway and the railing and structure of the bridge, we find this condition. This is a new project just outside Indianapolis on Interstate 70.

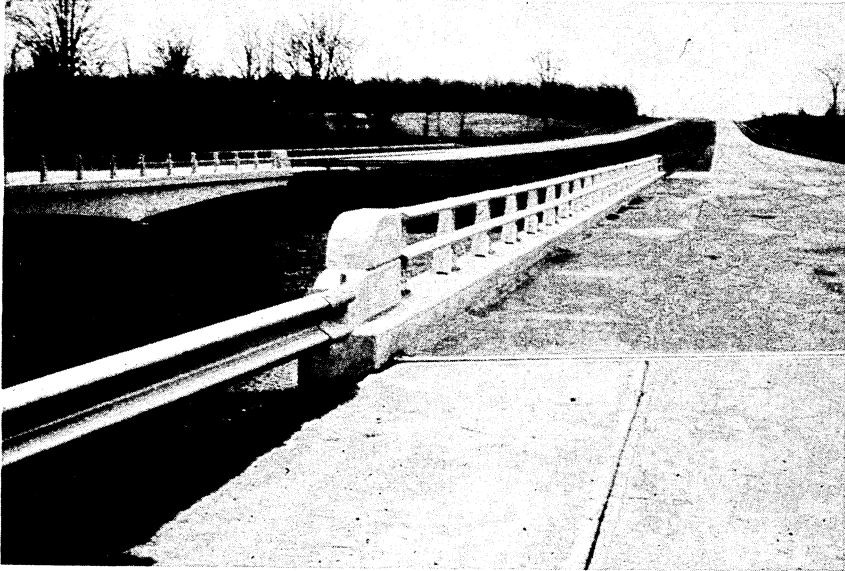
You will see that the shoulder is carried through on the normal width on this side. This is the lefthand shoulder.

You will see the absence of that wide walk. This again, the weak point is the lack of attachment of this rail to the structure.

Mr. PRISK. I think it has a weakness that we spoke of before, certainly the lack of any considerable transition between the roadway and the structure.

Mr. HUFF. I believe it should be said somewhere in this discussion that the basic fault is not having full shoulders completely across the bridge, and I think we will all remember that there were national
