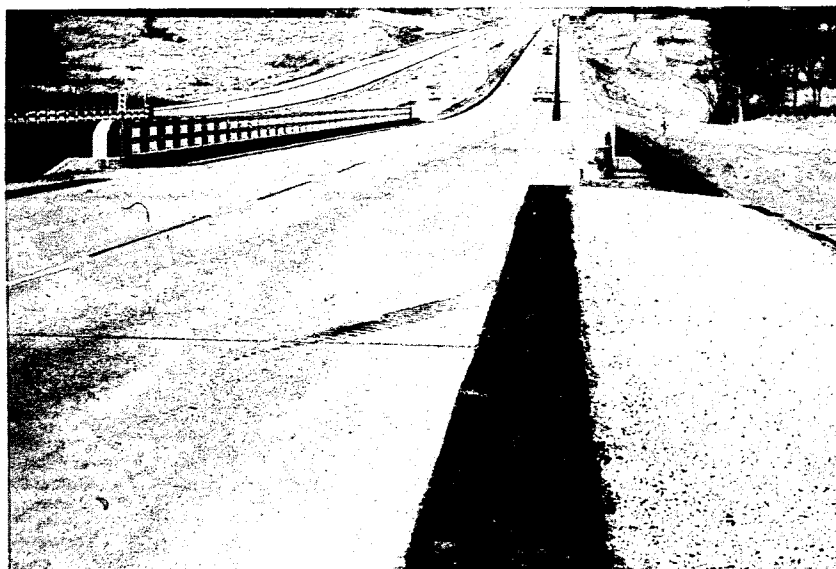
This is a closeup of another structure just a few miles farther along the way. This is the full shoulder width. This section here, to give you some dimension to judge by, this paving, this asphalt mat is 2 feet wide. You will see that there are about 2 feet 6 inches clear to the curb, and then a steel rail behind the safety walk on this bridge.

Mr. CONSTANDY. Mr. Prisk, I notice in each of these photographs, at the end of the bridge, the approaching end, there is always a yellow barrel with a number of dents in it. What is that there for?

Mr. PRISK. I did not ask anybody what that was there for and I do not believe I can do any more than guess that it serves to reinforce this yellow delineator up here, clearance marker, or hazard marker, as you will.

Mr. PRISK. This structure is almost exactly the same length as the other one and does have a different curb-to-curb width. As I recall, it was 32 feet curb to curb; the other one was about 40 feet, the reason being the difference in design period, one design a little earlier than the other one.
