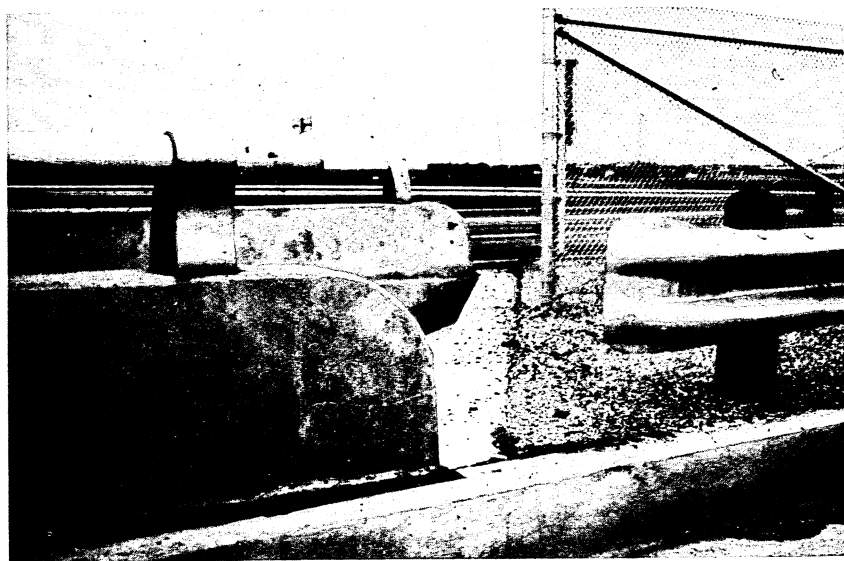
It is rather interesting on this same structure, that six of the eight possible points of contact of rail and structure have been fastened in the manner that we were just looking at in the previous slide. But two of them have not; on this side here is a place that is fastened and on this side it is not.

You see here they have even drilled—I do not know that you can make it out but there are two holes through here, Mr. Skeels; maybe they intended to put two bolts through there and for some reason did not put a second one through. I think there is only one place you can put a bolt through, anyway.
