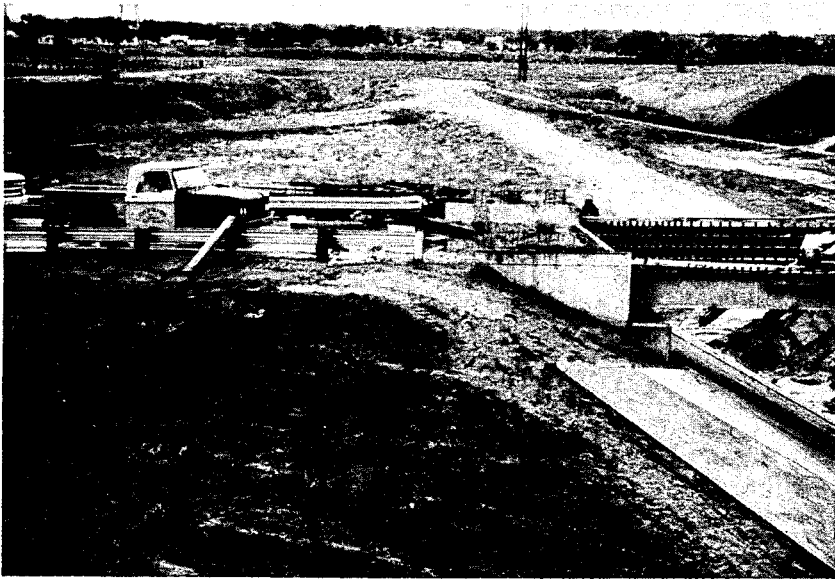
This is a very interesting picture, because in contrast with what we saw in Missouri a few minutes ago, where there was almost no rail in place, they are just starting to put the rail up ahead of some of the structures that have been open 6 or 8 months. Here they built the rail and finished it off before they even got a floor on the bridge. So this is 186° opposite, apparently, in their thinking.

There is no—I would point out, this bridge is under construction today; there is no connection at all between these. [Indicating.]

Mr. CONSTANDY. The picture certainly suggests that two different groups of people design and construct the elements which are to work together and function together to afford safety to the motorist. The guardrail is installed and finished ready to be open to traffic and the parapet at the end of the bridge has not even been built yet.

This would be in violation of that regulation over AASHO standards at the present time; would it not?
