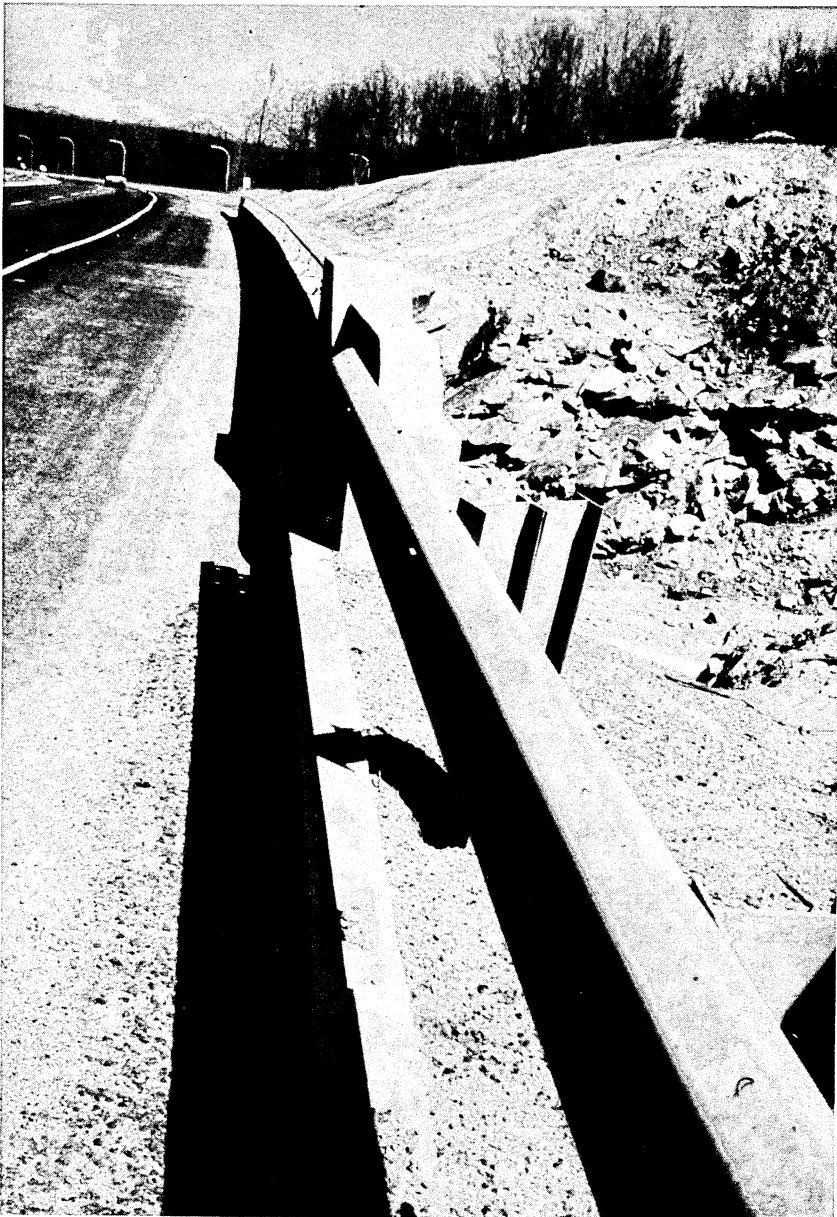
Mr. PRISK. Here is still another illustration of that curb down at the bottom, the brush curb. And upon crossing another structure showing the guardrail approach here. In this instance there has been no final anchorage yet of the post up here at the structure.

The curb is in front of the rail, again not too desirable.
