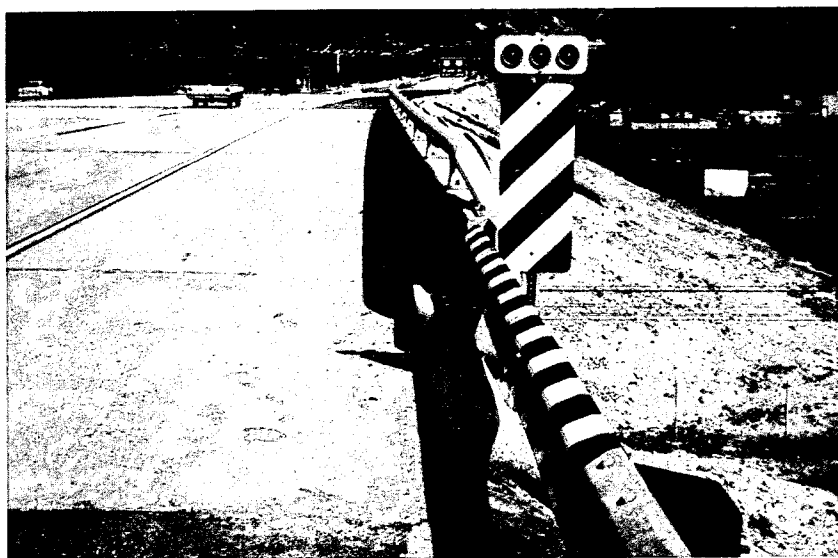
Moving along again, here is an attempt to anchor the guardrail to the structure on Interstate 80.
