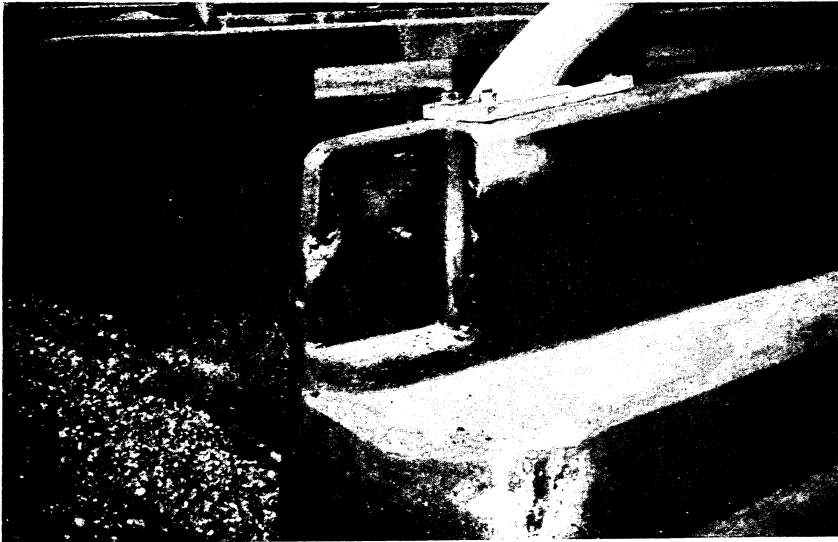
Mr. PRISK. All right. In any event, this is very similar to the previous condition. The design is exactly the same. The bolt is pulled out.

Here is the way this looks on one of the bridges where the rail is not in place. You can see the location of the bolt. Some of these are a little bent—it is expecting a great deal of one bolt.

Mr. SKEELS. I would just like to make a comment. This shows, really, a lack of appreciation on the designer's part of the tremendous forces that are involved in these typical impacts. The guardrail itself, as you recall, the sections are bolted together with four large bolts, two at the top and two at the bottom, with a minor mounting bolt in the center.

The guardrail will stand a tensile force of about 100,000 pounds. To bolt that rail to a bridge abutment with a single bolt, that looks to me as if it might fail at 5,000 pounds, indicates a misunderstanding of what one is trying to accomplish.

I do not think the designer really realized he was trying to fasten the rail to the bridge in order to obtain the tensile strength that the rail can deliver. In other words, I do not think his goal was properly spelled out to him.

Mr. WILKES. I am sure the designer of that connection was not aware of the horizontal force that would result from a vehicle struck against the rail, and did not realize it was intended this guardrail would
