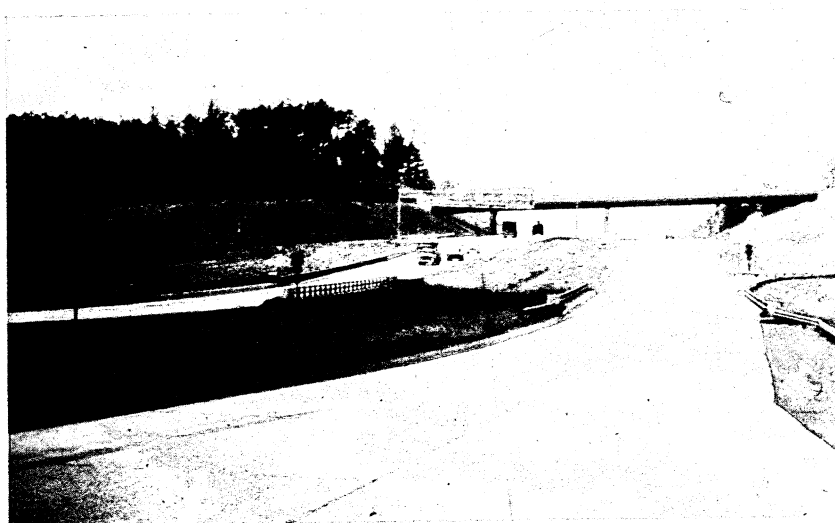
Mr. PRISK. Continuing, we find this condition at the end of the project in Georgia, where again you have dual bridges with very little guardrail protection at this point. This structure, which is at the end, this being a connection with Interstate 285, was built as a part of the old project. We were looking from the end of the work.

We have examined away from the project. That is the condition, perhaps the older condition, you might say.

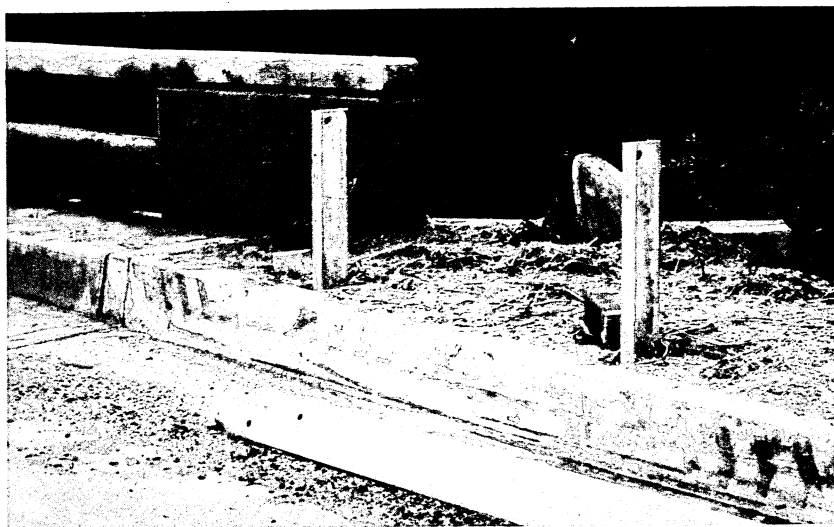
Now we look at some new work in the same State. We find out that bridge ends are being treated this way. You recall seeing in our review of the guardrail practices that the State highway department is starting to use these blocked-out sections and Z posts; and here you see them again, approaching the structure.
