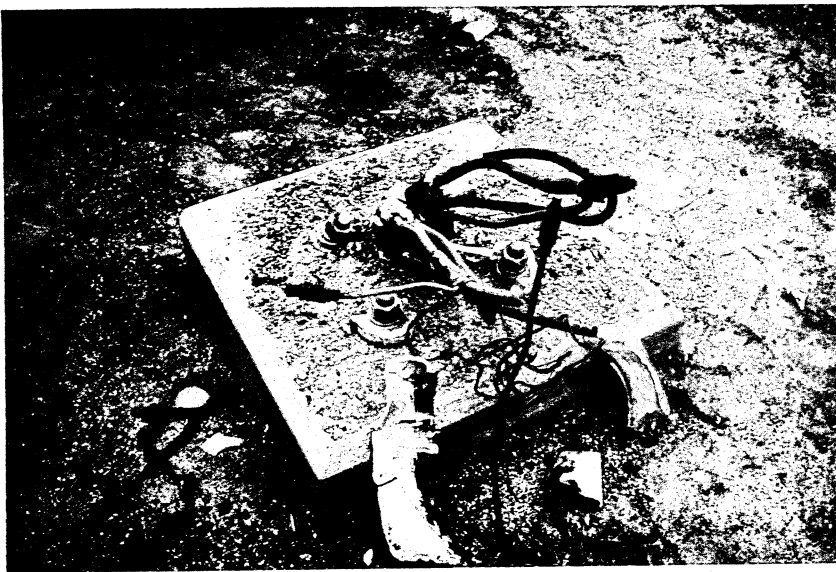
Here again is a closeup of that particular installation, the one most recently broken.

Mr. CONSTANDY. That picture shows something else, does it not, Mr. Prisk, the manner in which it is provided that the high-voltage lines will not cause an additional hazard by being broken. Could you explain that?

Mr. PRISK. Yes, I had mentioned that on the earlier slide, Mr. Constandy, that there was an automatic disconnect. These ends here and here pull away from the wiring inside the pole so that when it goes down, there is an automatic disconnect of the power, no opportunity for fires to develop or any short circuits in the line or even interruption of service to the other lighting units.

Mr. RICKER. You might note that that concrete base is about 2 inches out of the ground. That should be about the maximum, particularly when you consider erosion that may take place later on. Not having seen the pictures, I do not know whether you have some others that are higher. But I suspect that 2 inches is about the most that should be allowed to protrude.

Mr. PRISK. Very good observation. Glad to have it, of course. Most of these I would say are limited to within 2 inches.
