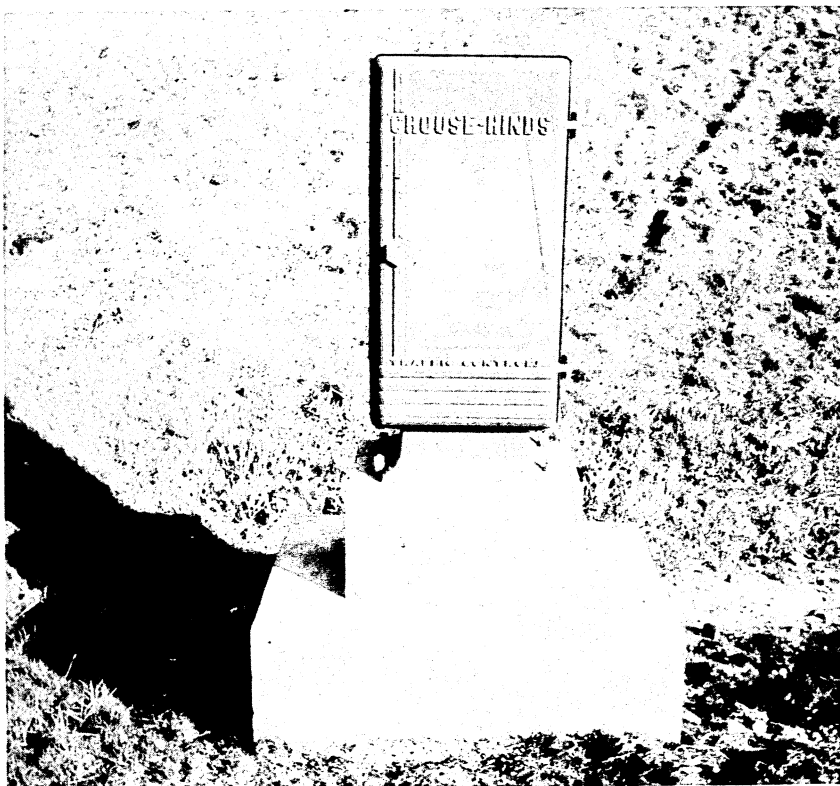
And then I show you this view of the same thing to give you an idea of where it is and its relevant size. This is the control system for the lighting that we are just looking at, and just dropped in here on a section of the tangent portion of I-95, all too close to the roadway. There is a slope, where this picture was taken, which rises up here and is clear perhaps within the right-of-way for possibly another 40 feet from that location. It could have been moved up the bank.

The only consideration I can understand for this location is that it is a little easier to get here and read the meter or service the equipment inside of the box.

Mr. CONSTANDY. It is unfortunate. Those two things were the only features which spoil an otherwise very good installation of lighting, the existence of that control box and the unfortunate existence of the two light poles inside the guardrail.
