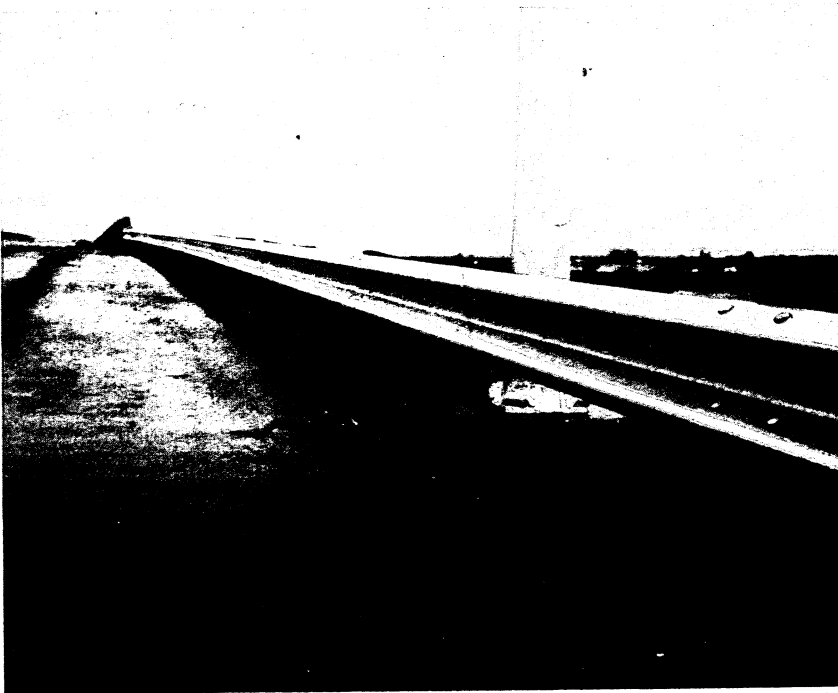
784

And this is the other complementing condition, steel pole, steel base all the way down behind the rail, slight exposure of the footing.
