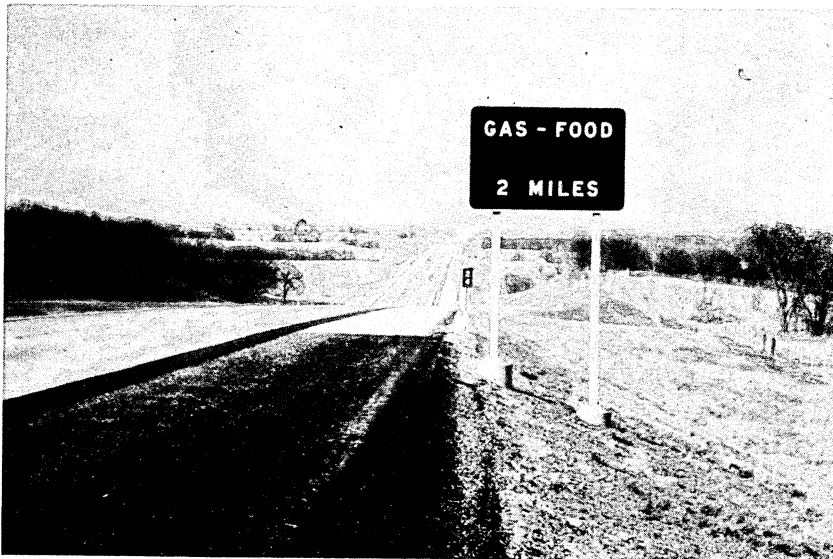
Mr. PRISK. Moving on, here is another similar installation for another purpose, service sign, "Gas, Food" marking, with exposed footings.
