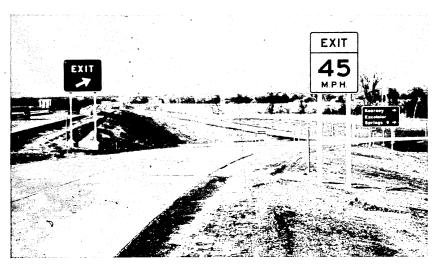
Here is an exit sign with exposed footings. Here is an exit sign, speed sign, on the right-hand side on I-beams. And in this case you will notice that the shoulder is paved to this point and then at this location you drop to a narrow shoulder. So that it would be possible, conceivably, to drive directly into it.

I would also call your attention to almost the forest of signposts down in this area. I cannot help but think that some improvement in this situation will be necessary.

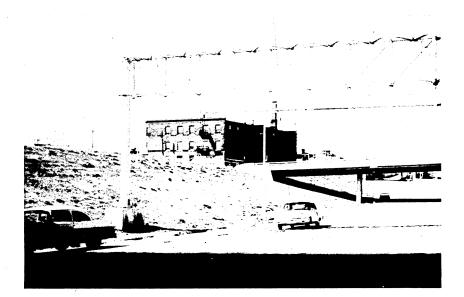
Urban area, off the project, specifically in Kansas City, in the freeway sections that are being built there now. This installation was found with the concrete pedestal supporting one end of an overhead bridge sign.
