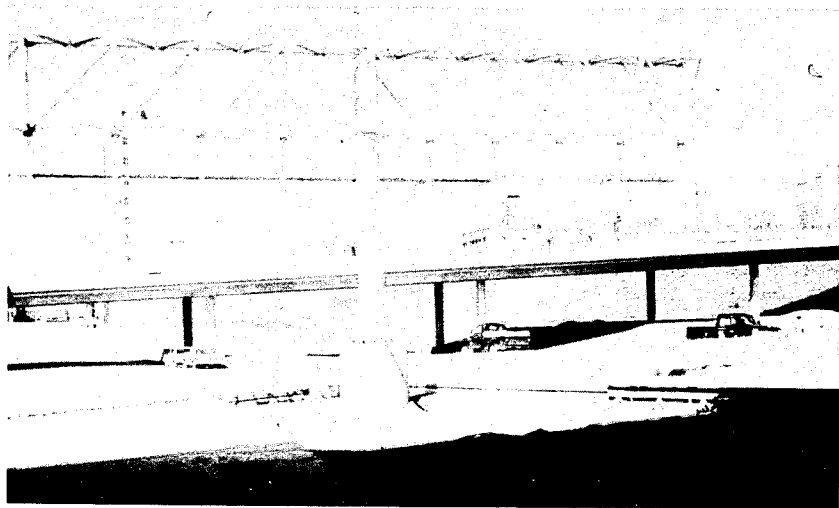
And this is the other end. You are looking here in the direction against traffic. So traffic comes down under this structure and must pass either side of this support. They really have themselves quite an obstacle there. Something like 8 feet from the front edge of this concrete pedestal to the curb that will outline it.

After some discussion on that job, incidentally, during the course of the visit, some additional negotiation and so on, this work is to be taken down and that hazard will be removed from the gore at that point.
