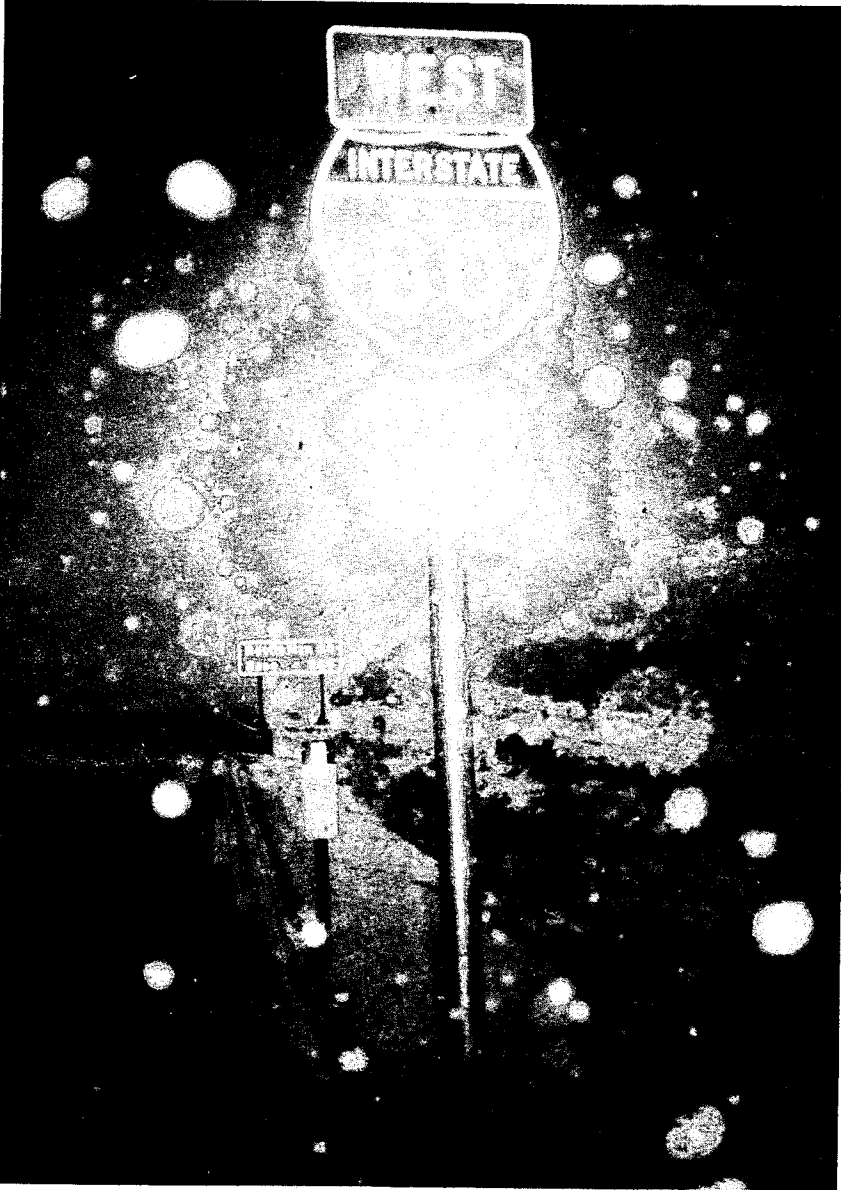
Here it is at night and in a snowstorm—essentially at night—taken with a flash photo. Here you can see the base out of the ground somewhat more than desirable, and the steel post. Both are very close by an asphalt curb.
