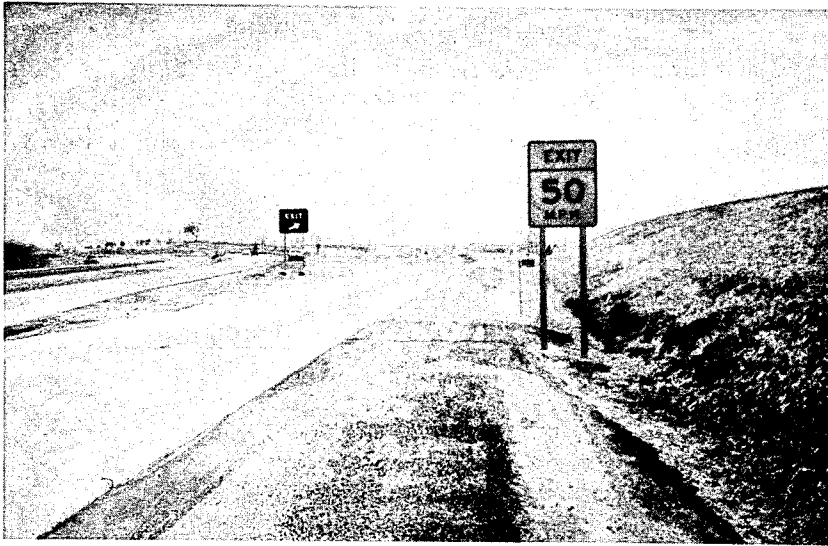
To move on down to that gore, we find the exit sign here with rather heavy concrete footings sticking out of the ground.

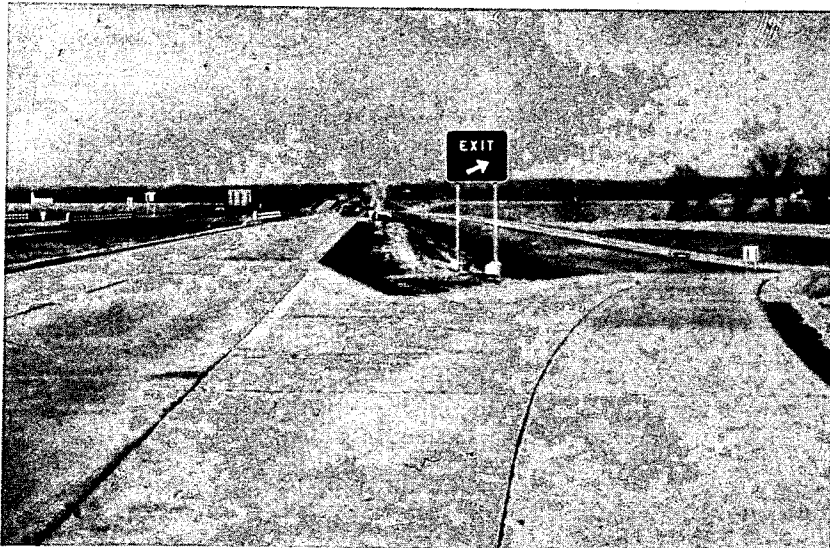
And here we are—again the place here where the grading of the interchange probably could not be accommodated to make this a real safe place to run into, but it does not look like you have too good a chance of getting in there with those footings in the way as they are.
