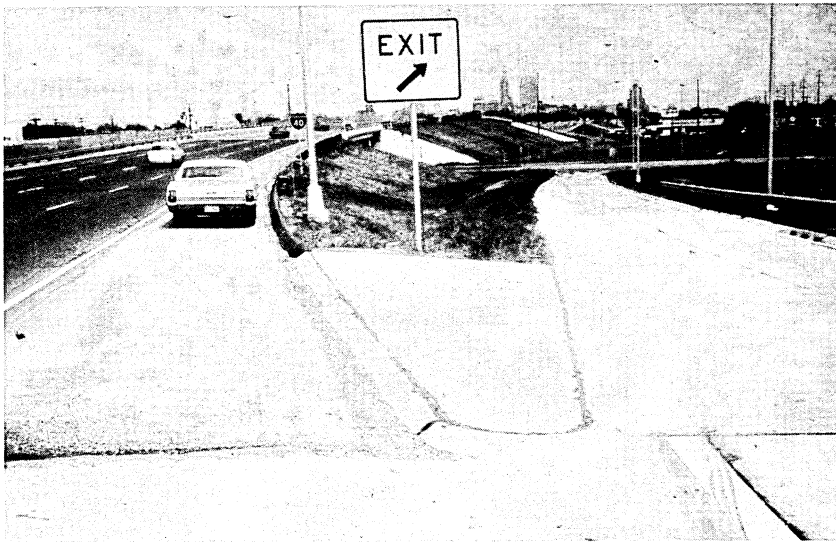
This we find in Oklahoma City, a version of what we saw in Ohio, except that the curb is higher here. In this case they use a pipe to support that same exit sign, although this is temporary here and probably a little bit smaller than the standard.

You see tracks of vehicles running across this gore indicating that the advance notice of that is not too good, or possibly the identification of it right at that point is not as good as it could be. Again, there is no differentiation in pavement color to help the driver identify the exact location of the gore.

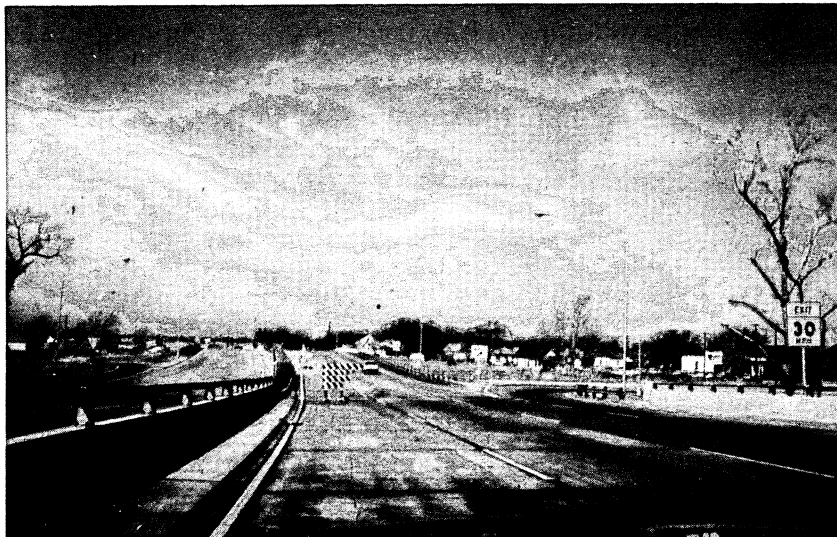
Here is a gore somewhat in the distance in this shot showing another place where it is relatively flat.
